HSVA Report No. 1663

**Research Study on the Sinking Sequence
and Evacuation of the *MV Estonia*
- Final Report**

Client: VINNOVA

Hamburg, May 05, 2008

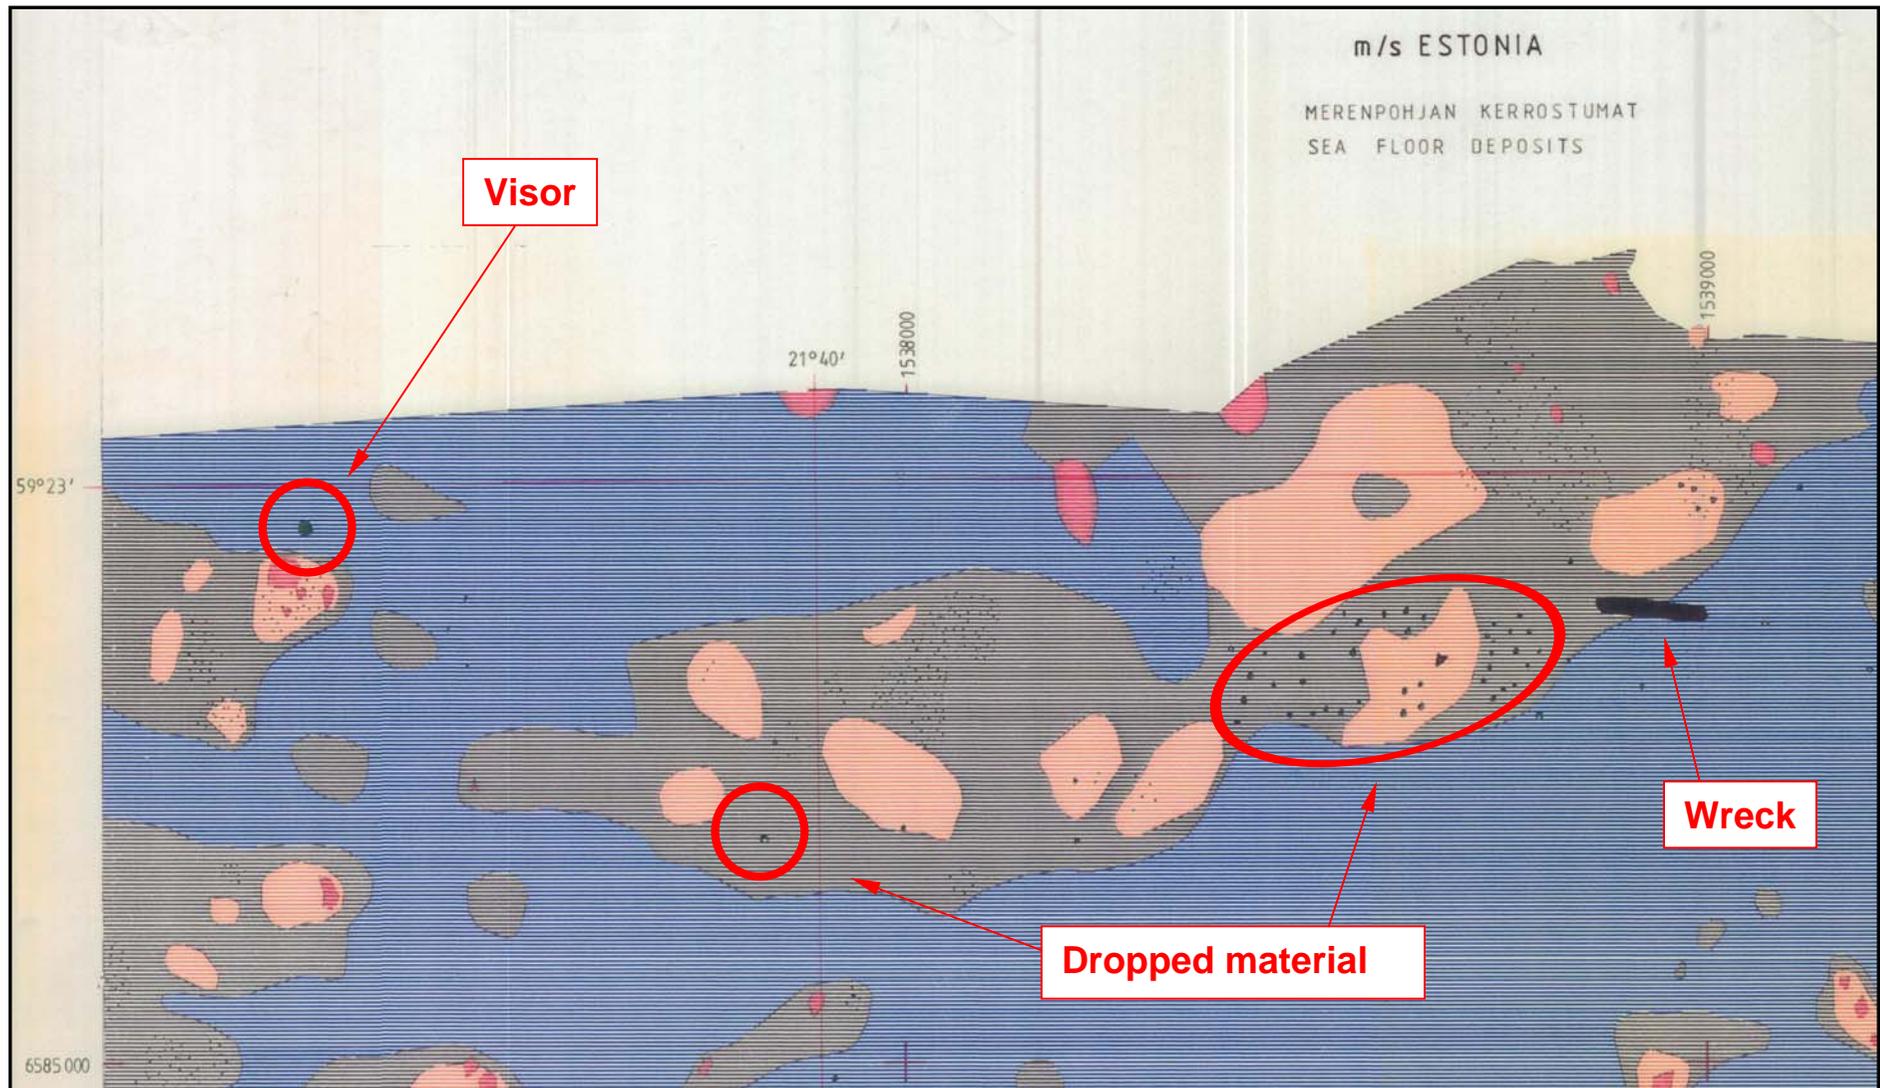
Fig. 3 Map of the sea floor deposits based on the sonar measurements in October 1994. The locations of the *MV Estonia* wreck, visor and areas of debris dropped from the *MV Estonia* are shown with red color. Map: courtesy of Dr. Nuorteva (1995) .

After the accident the bow visor was found on the sea bottom about one nautical mile west of the wreck. The positions of the wreck and the visor are shown in the map "Sea Floor Deposits" in Figure 3. The map is based on the sonar measurements carried out after the accident in 1994. Thus after the detachment of the bow visor the vessel must have advanced and drifted without the visor at least the mentioned one nautical mile. Considering the original course of the vessel, the location of the visor and that of the wreck, it drifted probably more than the one nautical mile. The speed of the damaged vessel towards the end of its sinking process must have been rather low. Therefore, based on the distance between the visor and the

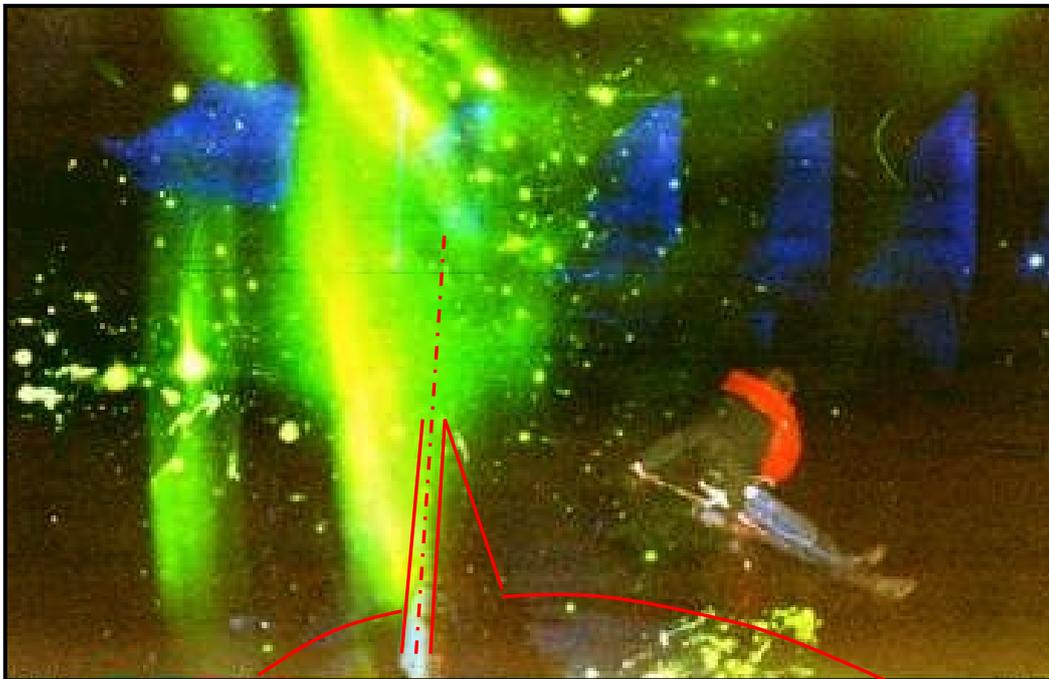
Fig. 5 Photograph taken towards the stern by passenger P92 sitting astride on the bilge keel. It is assumed here that the light blue “stripe”, framed by the red lines added by the author, is the tip of the bilge keel. The photograph shows that the area where the person is sitting must be the curved bilge area. The yellow-green and the deep blue areas are damage by sea water. Original photo: Scanpix.

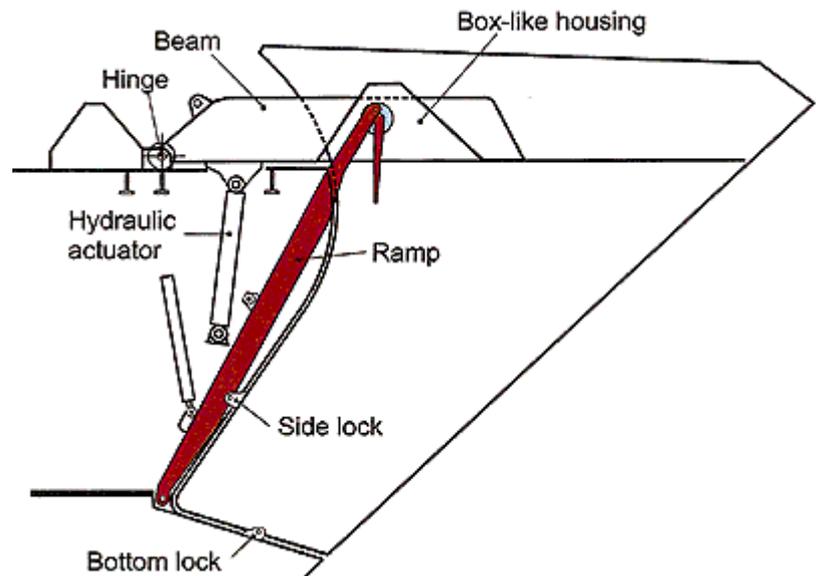
Fig. 13 Bow visor and ramp arrangement (JAIC, 1997).

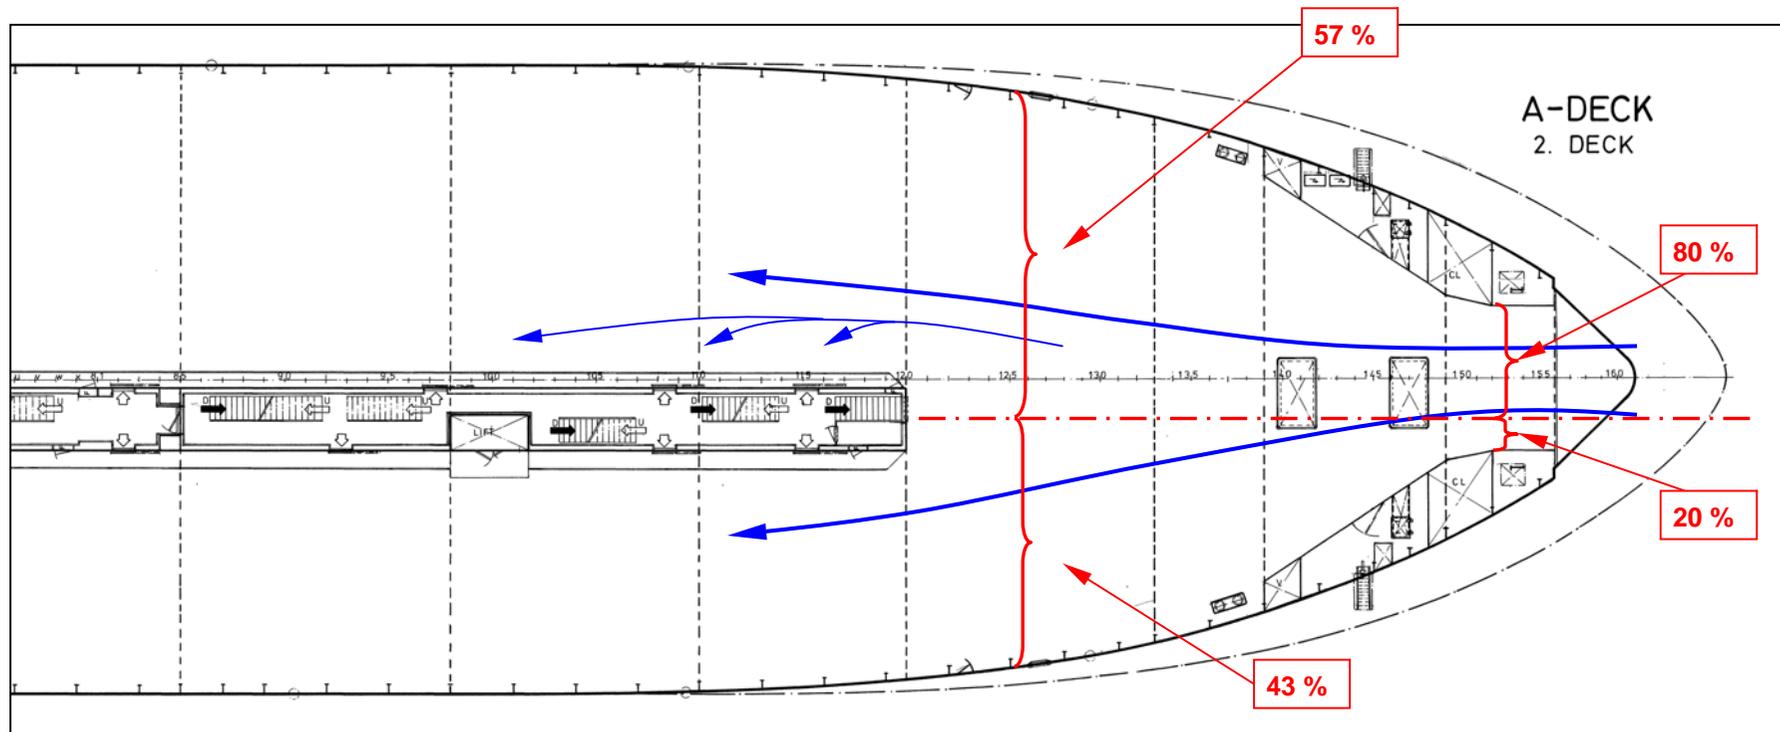
Fig. 21 Extract of the Jos L. Meyer Drawing No S590-02/3 showing the front part of the vehicle deck. If the ship has no list, about 80 percent of water at the ramp opening comes in at head seas on the port side of the centerline of the center casing, and only 20 percent on the starboard side. If we assume an even water distribution on the transverse direction on the vehicle deck just in front of the center casing about 57 percent of water flows to the port side of the center casing and about 43 percent to the starboard side. If the ship advances at the speed 15 kn and the ramp suddenly opens, the incoming waves hit the front face of the center casing with a considerable momentum in about 3.5 seconds.

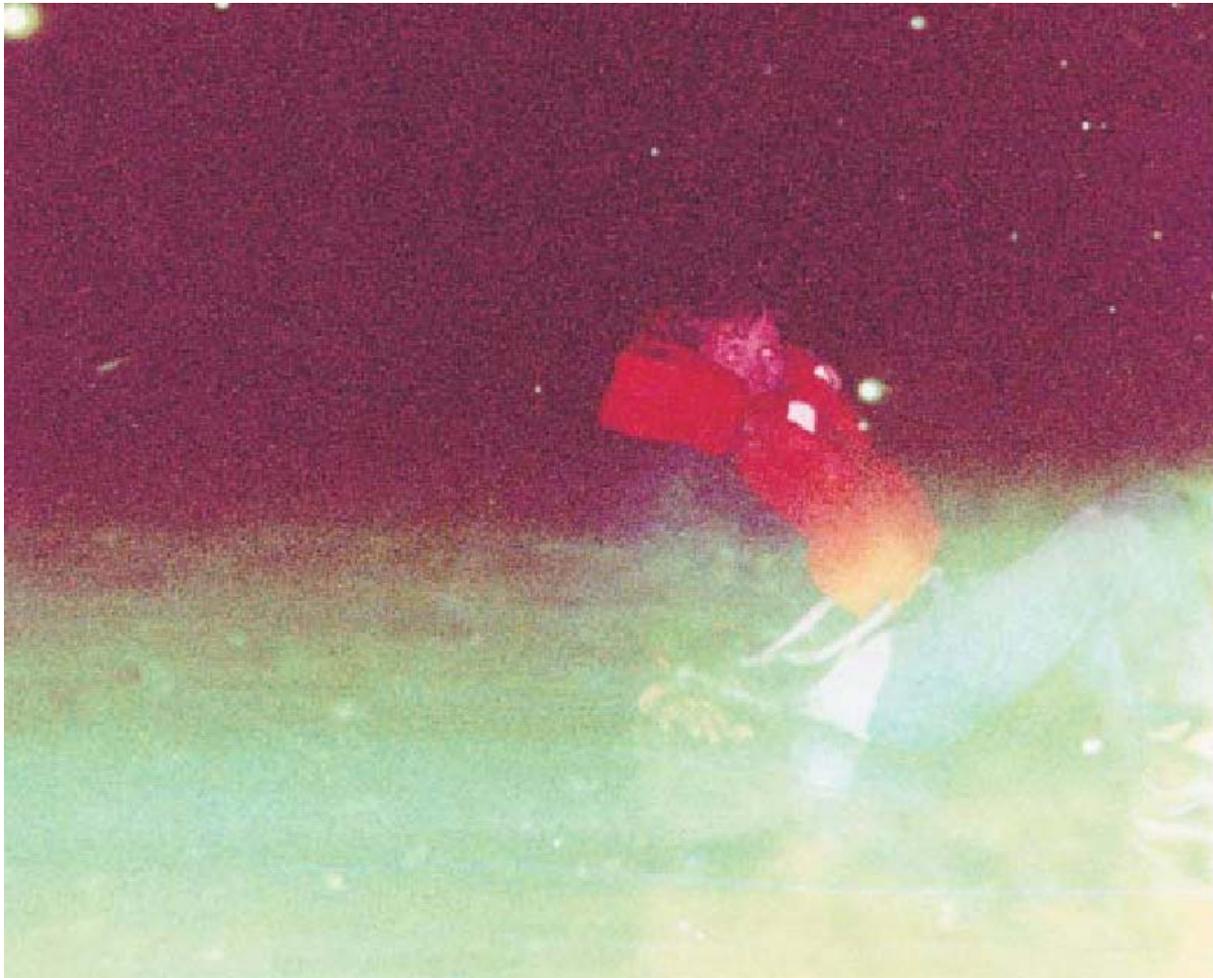
Fig. 52 A passenger has succeeded in getting out of the sinking *MV Estonia*, sits on the bilge area not far from the bilge keel towards the bottom of the ship heeled to 125°-140° and waits for a chance to get into a raft or into the 10°-11° C warm water with 4 m high waves. At this point his chances to survive are already relatively high, about 50 percent. The photograph was taken by Passenger P92 on 28.09.1994. The green color is caused by damage on the film due to sea water.

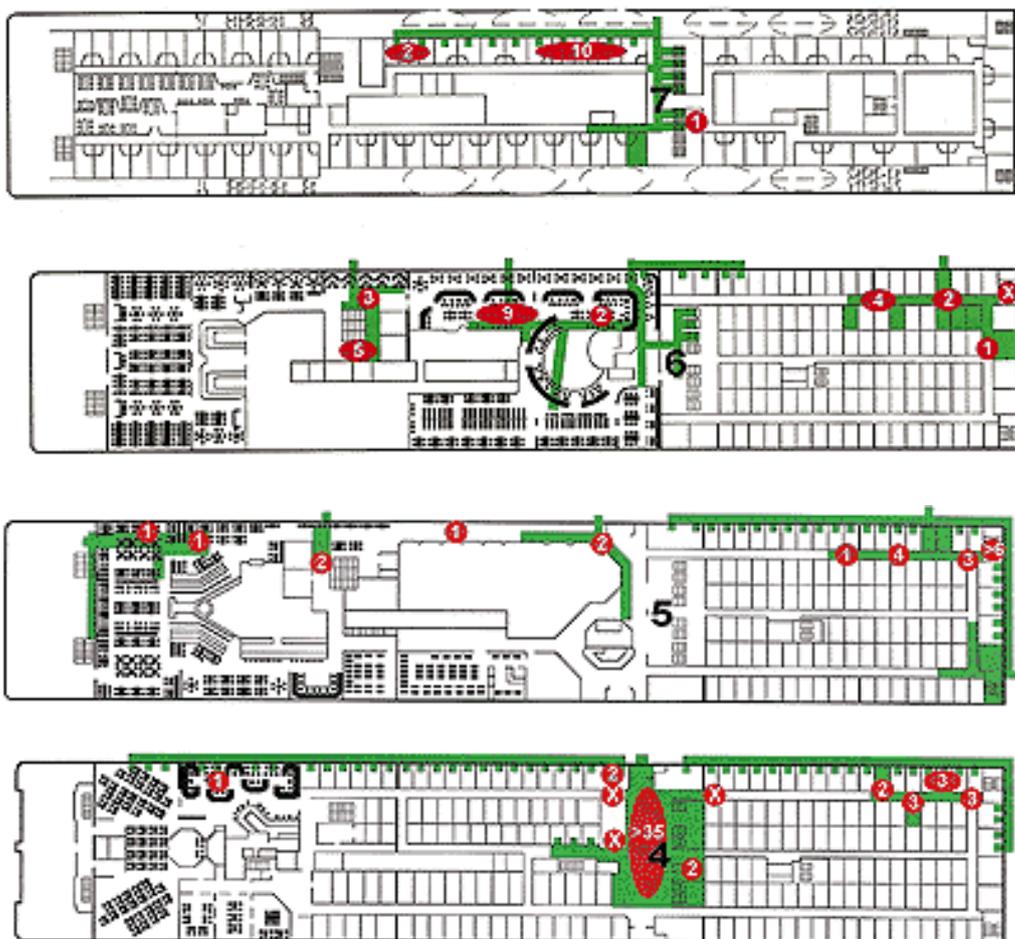
Fig. 77 Number of victims in the areas surveyed by divers (JAIC, 1997).
