HSVA Report No. 1663

**Research Study on the Sinking Sequence
and Evacuation of the *MV Estonia*
- Final Report**

Client: VINNOVA

Hamburg, May 05, 2008

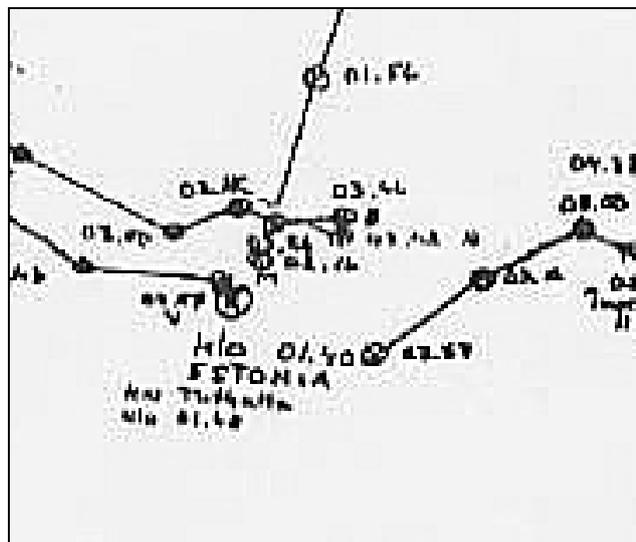
There is only one position marked for the *MV Estonia* between 01:40-01:48 in the map detail shown in Figure 4. See also the similar Figure 17.1 of the JAIC Final Report (1997) reproduced as Figure 8. This supports other information suggesting that the ship stern was already at the sea bottom around 01:40 and that the drifting of the vessel had stopped. The current turns the ship, pivoting the ship around its stern on the sea bottom, towards its final orientation on the sea bottom.

Fig. 4 Extract of a map showing the movements of the rescue vessels (GE Encl. 24.394).

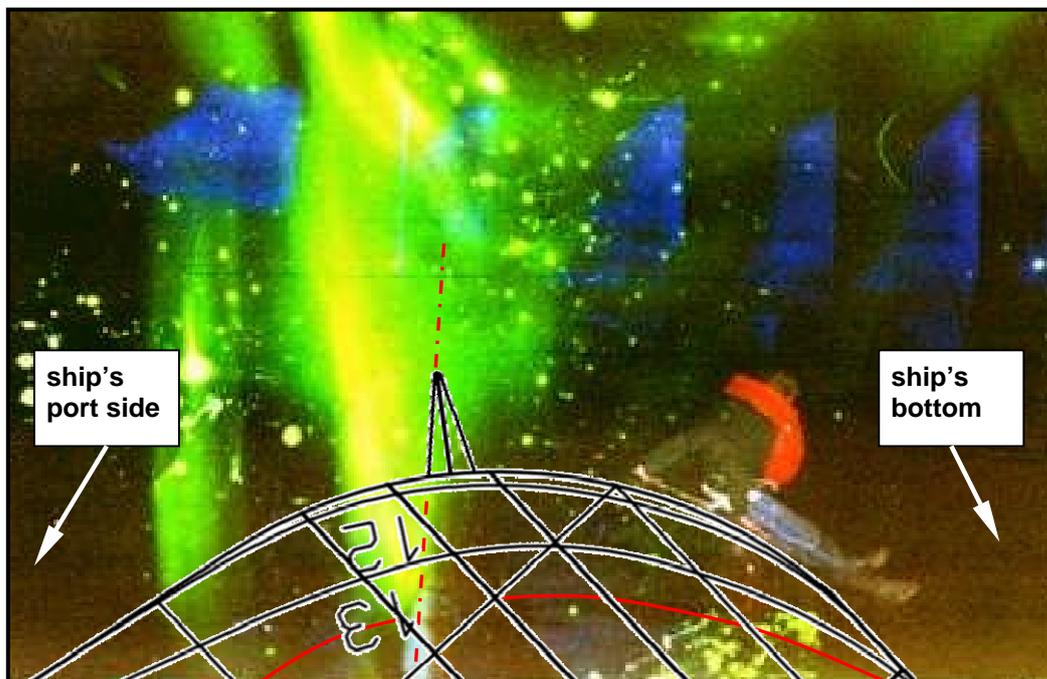
Figure 6 shows the same photograph by passenger P92 as above. A part of the ship body plan is added. The distance between the diagonal black waterlines of the body plan is 0.5 m. The black triangle inclined 7° - 8° left shows the position and height of the bilge keel, which has approximately correct size with respect to the size of the sitting person. The inclination of the body plan, i.e. ship, is 133° . Figure 7 shows the body plan of the ship inclined 133° in order to illustrate the situation shortly before the ship sank. In Figures 5 and 6 in the light yellow-green area also an almost vertical, very fine light blue line can barely be seen. The line is visible only on the upper part and it would appear to end somewhere little left of the bilge keel. It is possible that this line is real and not damage in the film and shows an edge of the fin stabilizer still standing out further away. The position of the line would match well with that of the stabilizer.

Fig. 6 Same photograph by passenger P92 as above. Part of the ship body plan is added. The black triangle indicates approximately the position and height of the bilge keel, which is comparable to the size of the sitting person. The inclination of the body plan, i.e. ship, is 133° . Original photo Scanpix.

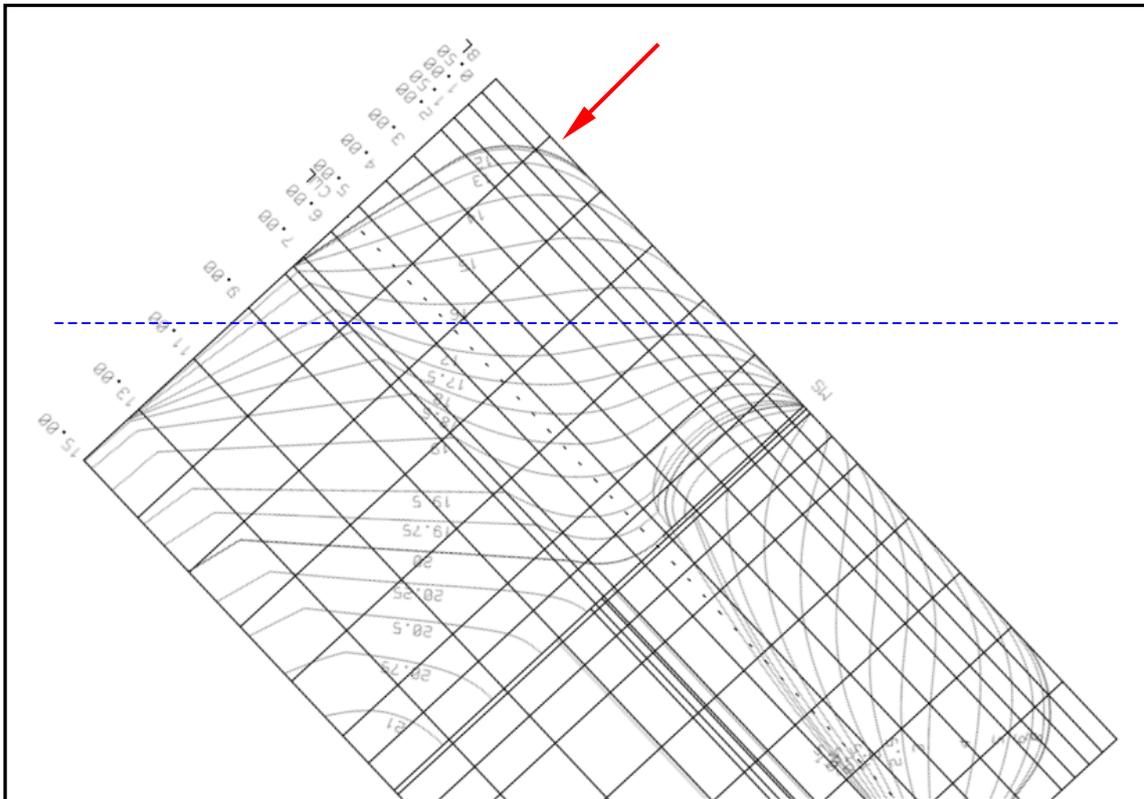
Fig. 7 Body plan of the ship inclined 133° seen from the bow. The red arrow shows the approximate position of the person in the photograph shown in Figures 5 and 6. The blue horizontal line is based on hydrostatic calculations. It shows the water level very approximately at the time and in the assumed position, where the photograph was taken.

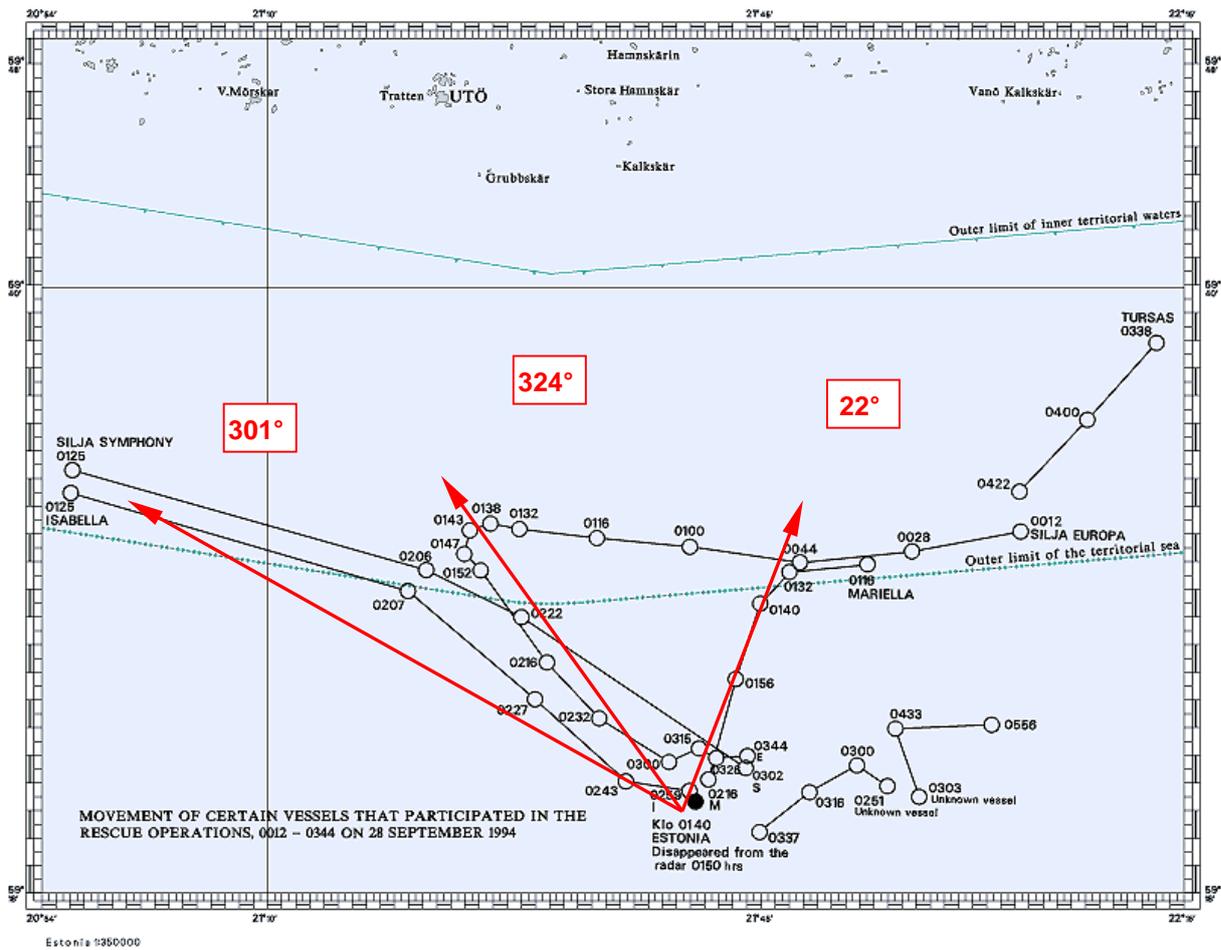
The wreck of the ship lies in the direction of approximately 95° , that is, the stern points in the direction 275° . If the stern of the *MV Estonia* pointed somewhere in the direction between 301° - 324° when the photographs were taken, it means that the *MV Estonia* turned about 15° - 40° towards port little before it came to rest on the sea bottom. It was concluded elsewhere that the *MV Estonia* sank stern first. If so, the prevailing current in the direction of east-northeast (ENE, 67.5°) would have the tendency to turn the bow of the vessel pivoting around its stern on the sea bottom towards the direction of the current. This would explain the difference between the most likely orientation of the ship when drifting and the direction of the wreck on the sea bottom. Based on arguments above, it is assumed here that around 01:35-01:40 the ship had a heeling angle of about 125° - 140° with the ship's stern pointing approximately towards the direction of 300° - 325° .

Fig. 8 The figure shows the tracks of some vessels during and after the accident. The tracks are based on radar observations (JAIC). Three possible viewing directions of the passenger P92's camera are also shown.

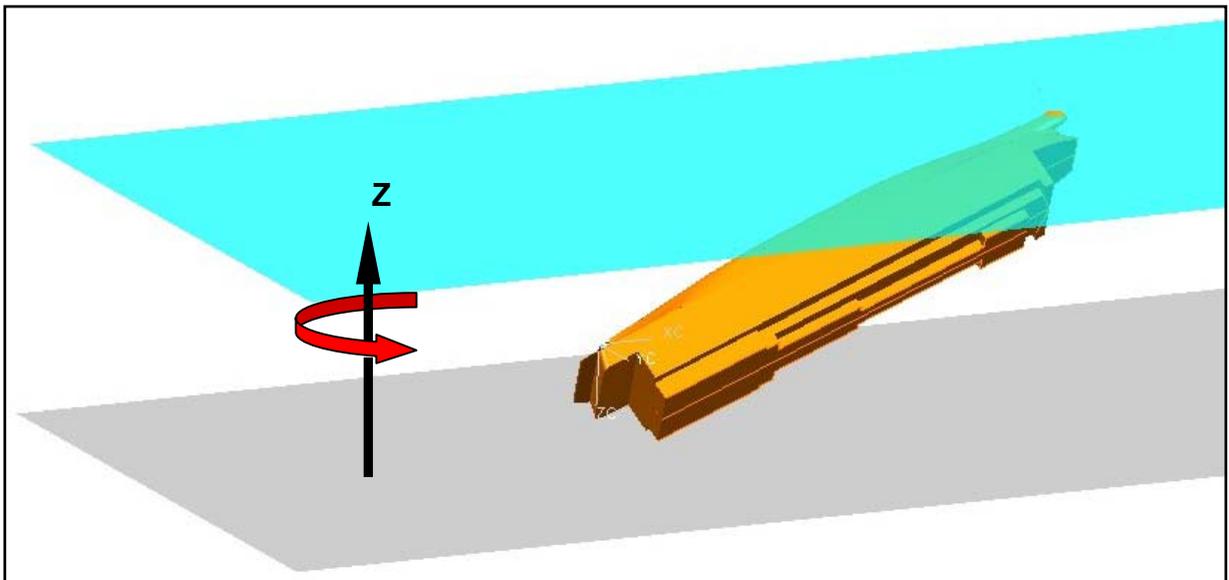
The water depth at the stern of the wreck of the *MV Estonia* is 74 m according to the JAIC Final Report. If the ship had a heeling angle of the mentioned 133° to starboard and a trim angle of about 22° the very tip of the ship bulb is just out of water when the ship stern touches the bottom. Figure 9 illustrates the situation.

Fig. 9 The *MV Estonia* with a heeling angle of 133° to starboard and a trim of 20° . The vessel must have turned about $15\text{--}40^\circ$ to port before it came to rest on the sea bottom.

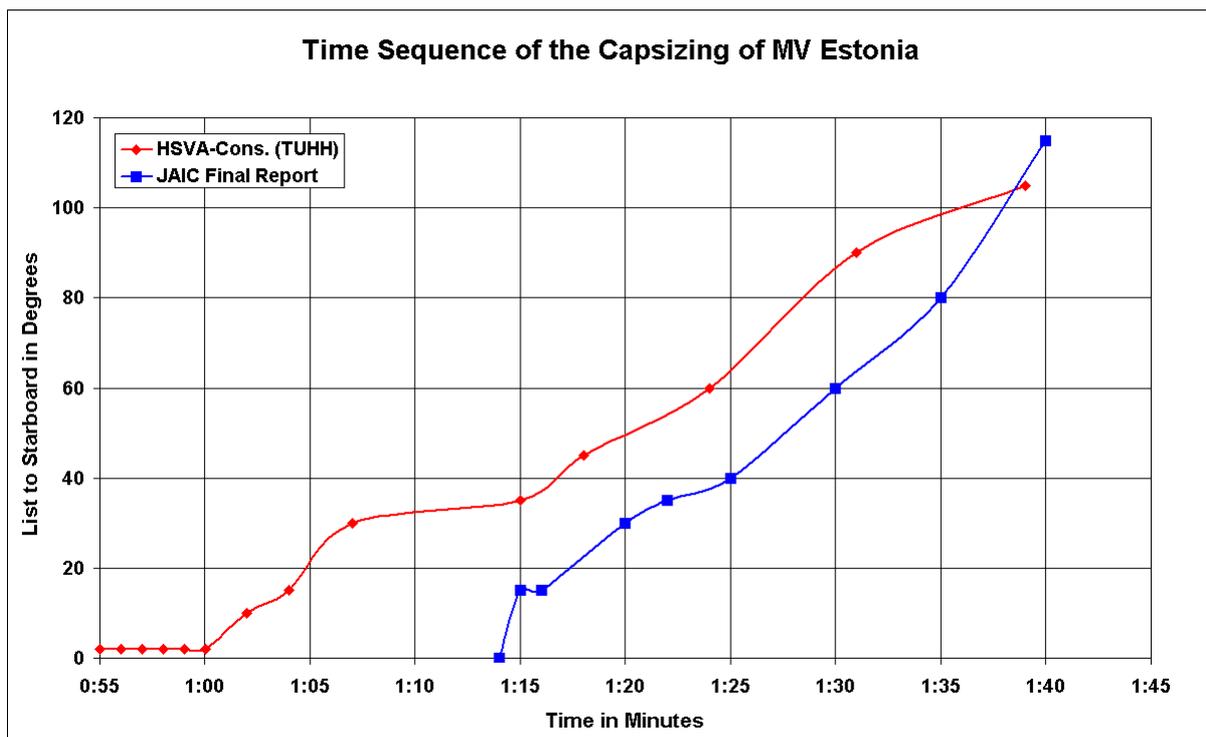
A new time sequence of the course of the events during the accident in form of ship's list as a function of time was established purely on the basis of the survivors' testimonies by the TUHH, the second partner in the HSVA–Consortium. This sequence of the ship's list is one of the crucial facts to be reproduced with the motion simulation of the damaged ship. Figure 10 shows the new time-history of the list of the *MV Estonia* together with the list development according to the JAIC. There is a clear difference between these two time-histories. The HSVA consortium believes that the actual accident started earlier, around 01:00, and not at 01:14 as stated by JAIC. The values of list in the TUHH-curve are based on subjective observations made by the survivors. It is possible that the actual values of list were at certain points somewhat lower than those felt and reported by the survivors.

Fig. 10 Development of list to starboard during the *MV Estonia* accident.

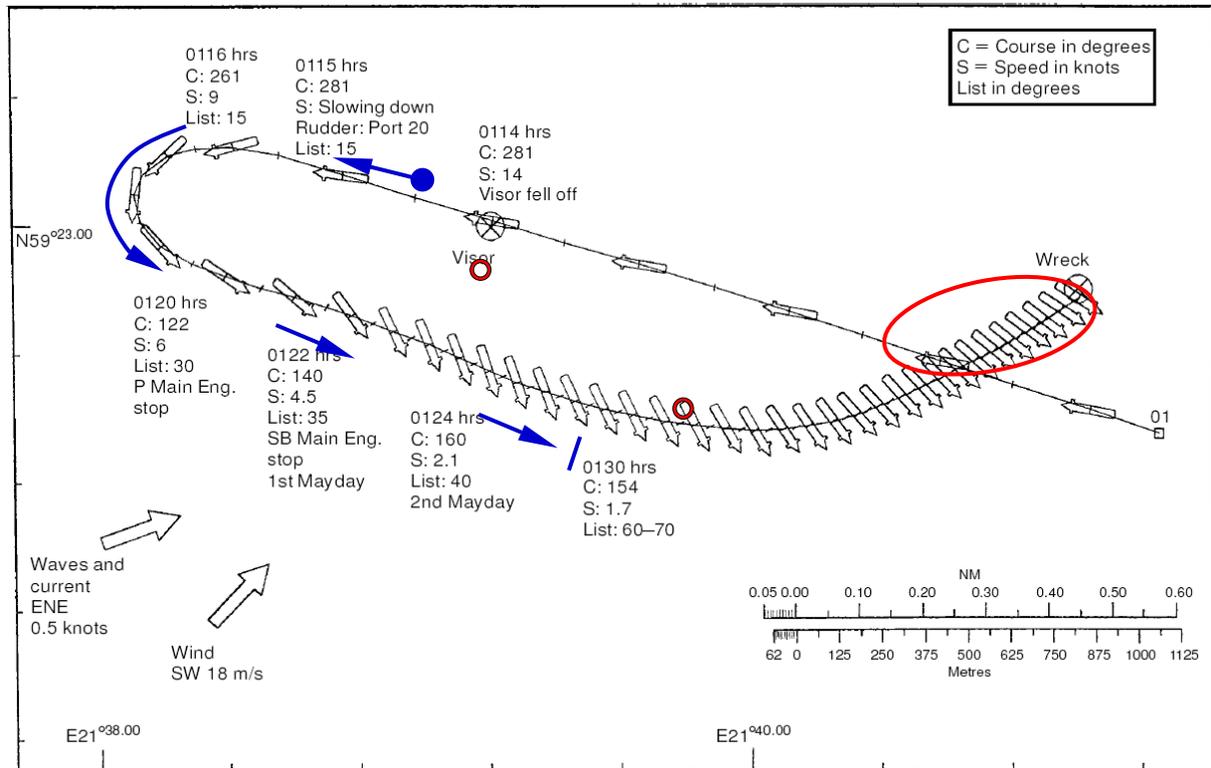
Figure 11 reproduced from the JAIC Final Report (1997) shows the *MV Estonia's* track during the last hour. The red circles and ellipsoid mark areas, where the visor, an unknown object and various loose items lay on the seabed, based on sonar measurements carried out in October 1994 (Nuorteva, 1995). A corresponding map of the sea floor deposits obtained with

these measurements is shown in Figure 3. These are hard facts in the *MV Estonia* investigation: The vessel must have passed very close to these points. The blue arrows in the figure show the part of the track, which is subject to be defined with the help of the survivors' testimonies and physical facts related to the behavior of the damaged vessel in the seaway of the night to September 28, 1994.

Fig. 11 *MV Estonia's* track during the last hour, as composed by the Navigation Simulator at the Maritime Academy in Kalmar, Sweden (JAIC, 1997).

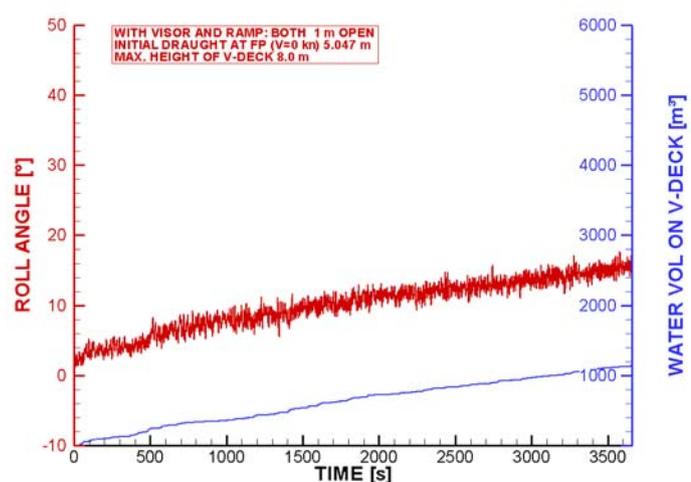
Simulation result: In this scenario the inflow rate of about $10\text{-}20\text{ m}^3/\text{min}$ is relatively small from the point of view of the ship stability. However, also this amount certainly appears considerable for an observer on the vehicle deck or somebody observing this via a TV-monitor, like the crew in the engine control room did. The water accumulates slowly on the vehicle deck; in ca. 26 min the list of the ship reaches 10° . The list increases gradually as the water volume on the vehicle deck increases. If no corrective action were taken, the ship would be in danger to capsize after more than 3 hours. Figure 14 illustrates the situation. The water volumes shown in Figures 14-20 are computational water volumes, which must be multiplied with the permeability (0.82) to get the real values of the water volume on the vehicle deck.

This scenario may have taken place before the ramp opened, but not for very long, as the gradually increasing list, e.g. 7° after 10 min, would have been noticed sooner or later by the crew. The simulation does not indicate any sudden heeling or other sudden ship motions.

- ⇒ The flooding rate in this scenario is too slow for it to be the final scenario for the flooding of the vehicle deck.
- ⇒ The scenario can be true for the very initial phase of the accident, but not for very long, as the slowly increasing list would have been observed by the crew.

Fig. 14 Roll angle and computational water volume on the vehicle deck when both the visor and ramp are about 1 m open.

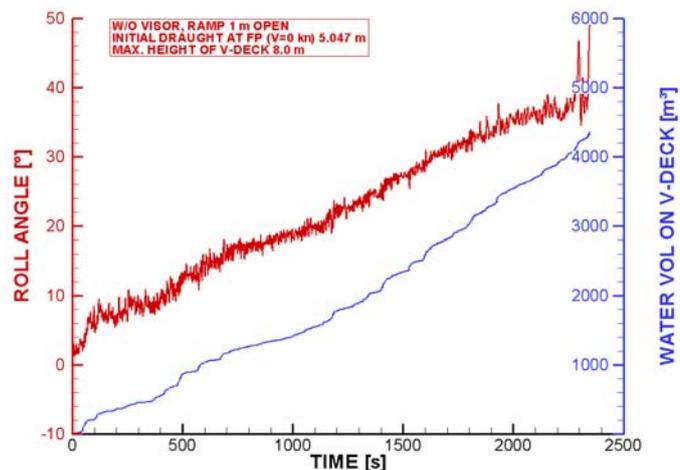
The water accumulates on the vehicle deck; in ca. 10 min the list of the ship reaches 15° . The list increases monotonously as the water volume on the vehicle deck increases. If no action were taken, the ship would be in danger to capsize in about 40 minutes. Due to the gradually increasing list the situation would have been noticed by the crew relatively soon. Even after a considerable list there would have been enough time to take action against the water inflow on to the vehicle deck. The simulation does not indicate any sudden heeling or other sudden ship motions. Figure 15 illustrates the situation.

Fig. 15 Roll angle and computational water volume on the vehicle deck without visor when the ramp is about 1 m open.

- ⇒ The flooding rate is perhaps somewhat too low for this scenario to be the final scenario for the flooding of the vehicle deck.
- ⇒ The inflow to the vehicle deck could hardly remain unnoticed by the crew. In this scenario the ship gets a list of $14-15^\circ$ in 10 min. After this observation the crew would still have had sufficient time to take action against the inflow.
- ⇒ This scenario does not fit to the known technical facts reported by the JAIC.

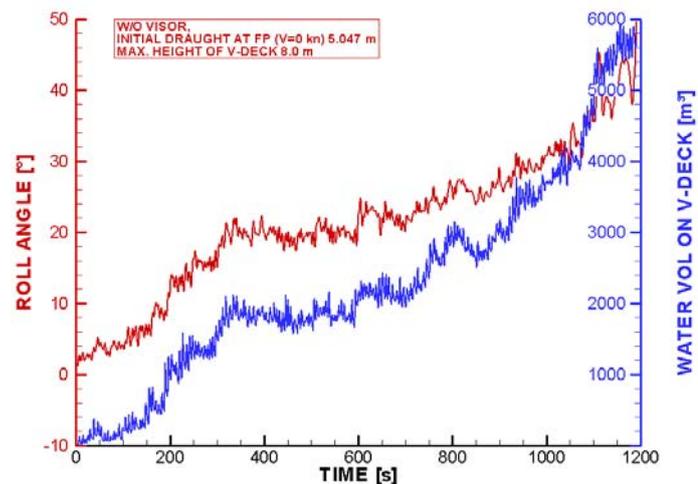
Notice that the curve in Figure 16 describing the water volume on the vehicle deck has a somewhat rougher look than the earlier curves shown in Figures 5-6: This is due to the open bow ramp, which allows more water sloshing in and out of the vehicle deck than in the earlier cases with the bow ramp only about 1 m open.

- ⇒ The flooding rate is suitable for this scenario to be the main scenario for the flooding of the vehicle deck.
- ⇒ The inflow to the vehicle would certainly be noticed by the crew. In this scenario the ship gets a list of over 10° in 3-4 minutes. If the crew in this scenario would not rapidly slow down or turn the ship, it would capsize. This scenario can be considered in generally to fit with most testimonies by survivors and to known technical facts.

Fig. 16 Roll angle and computational water volume on the vehicle deck without visor when the ramp is fully open.

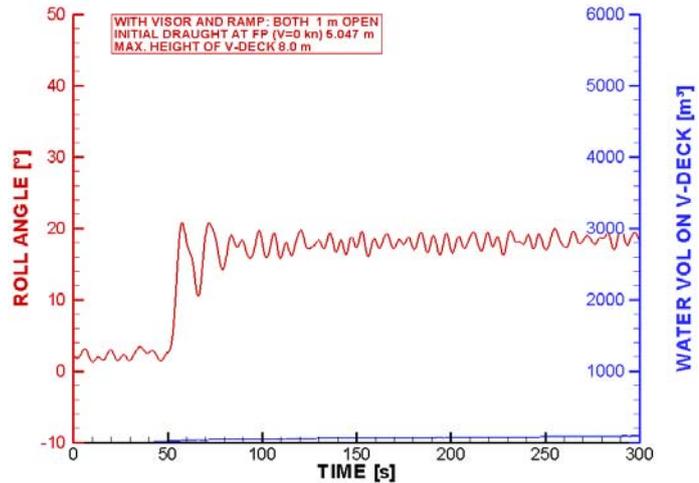
Fig. 17 Case (a): Roll angle and computational water volume on the vehicle deck, when both the visor and ramp are about 1 m open, start of turn at $t=50$ s.

In the Case (a) the simulations provide a step of 18-19° in the heeling angle curve, the heel angle reaches 20° and remains high, as shown in Figure 17. The transient (roll) oscillations after the step dampen rapidly. The water inflow on to the vehicle deck is not strongly influenced by the increased heel of the vessel, and the ship list remains practically constant. The water volume on the vehicle deck is in this particular case small. The situation has an almost quasistatic character and does not appear to correspond as well with the survivors' testimonies as the Case (c) below.

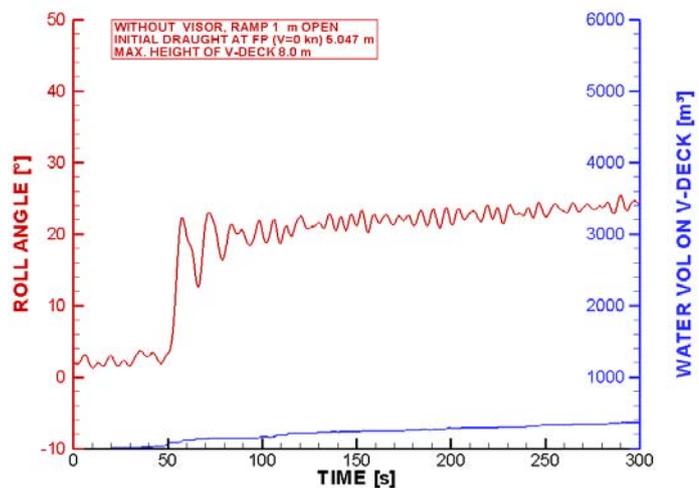
Fig. 18 Case (b): Roll angle and computational water volume on the vehicle deck, without visor, with the ramp about 1 m open, start of turn at $t=50$ s.

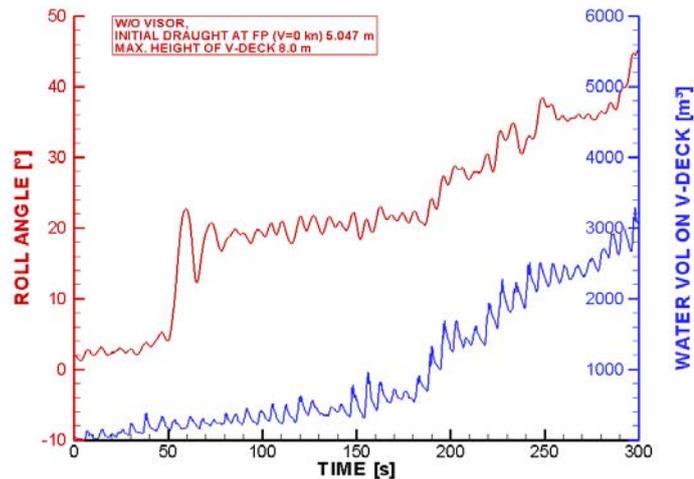
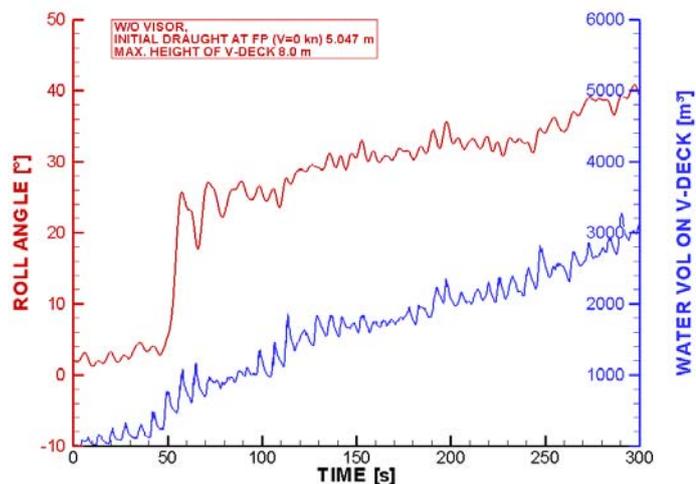
Fig. 19 Case (c): Roll angle and computational water volume on the vehicle deck, without visor, ramp fully open, start of turn at t=50 s. First realization of random waves.

Fig. 20 Case (c): Roll angle and computational water volume on the vehicle deck, without visor, ramp fully open, start of turn at t=50 s. Second realization of random waves.

to the sudden heel. Figures 19 and 20 illustrate the case with two different random wave realizations used in the simulations.

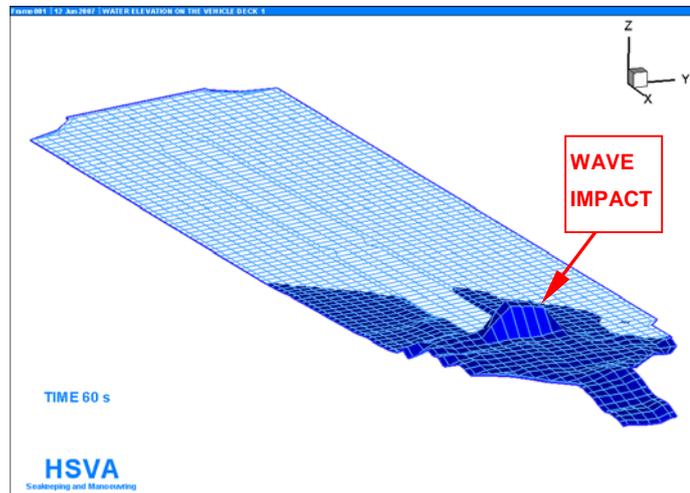
See the incoming wave hitting the front face of the central casing in Figure 22. The numerical grid on the vehicle deck is coarse, and the shallow-water-equations used in the computations are an idealization of the reality. Thus this small detail cannot be described very accurately by the numerical model, but in reality the wave at the front face of the central casing would have splashed water high up making the video camera fixed on this front face wet, as described by three crew members in the Engine Control Room. It is likely that this can take place only when the ramp is open.

Fig. 22 Waves on the vehicle deck coming through the fully open ramp slosh against front face of the central casing and splash water high up. This is a very early phase of the flooding

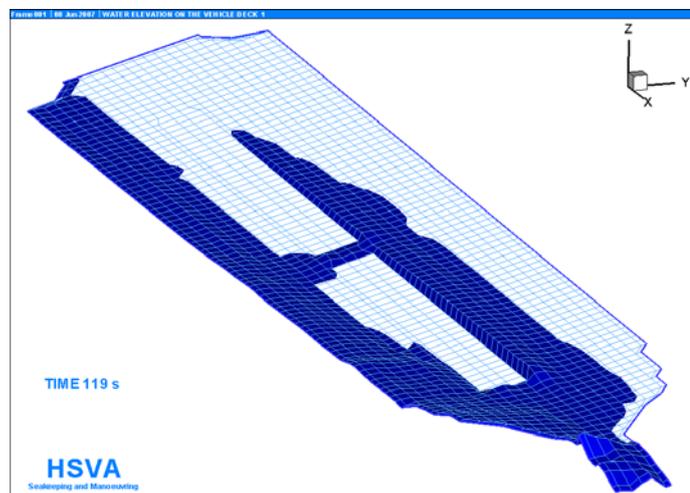
Fig. 23 Waves slosh water onto the vehicle deck through the fully open ramp. The flooding starts from the bow. Before the turn starts the heeling angle is relatively small.

In the ECR Motorman C7 was looking into a monitor showing the camera view towards the pilot door located in front at the starboard side of the ship. He reported water sloshing in this area between the cars and reaching up to the level of the cars, that is, 40-50 cm high

(Kurm/C7, 2007). In the simulations the water sloshing on the vehicle deck almost always floods this area. Thus the simulated results are in full harmony with the statement by C7.

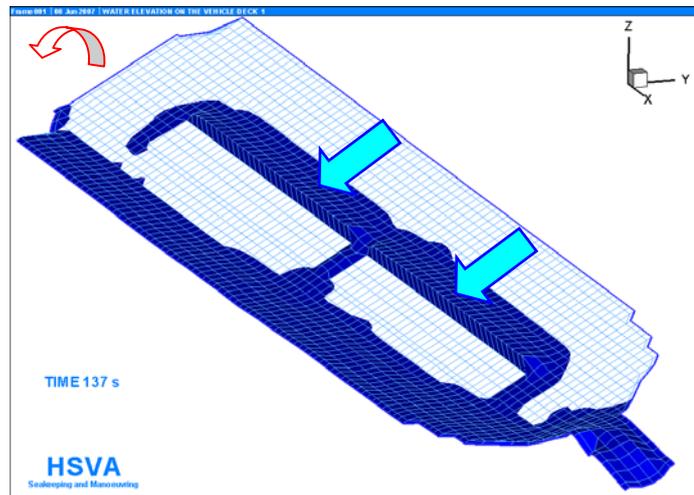
Fig. 24 When the turn has started the ship heels suddenly, the water on the vehicle deck rushes to starboard and the water level rises momentarily high on the port side wall of the central casing as it flows towards the lower starboard side.

A further interesting point is added when one looks what happens on the vehicle deck, if the vessel makes a turn. When the vessel starts the turn to port, it heels suddenly to starboard, and the water on the port side of the vehicle deck flows towards the center casing, where the water level rises and in addition the water sloshes high against the port side central casing wall and can easily flow into the staircases and from there down on to Deck 1 below. Figure 18 illustrates this moment. Many of the cabins of those survivors, who reported water on Deck 1 are located directly starboard of the staircases, that is, “downhill”, exactly where water would flow in a ship having a significant starboard list. See Figures 25 and 26.

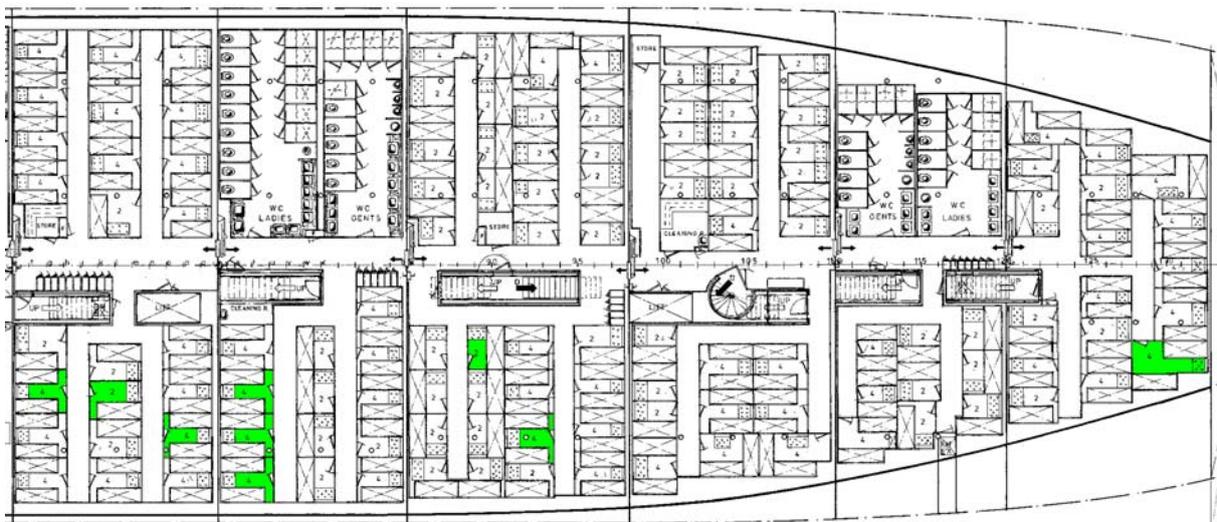
Fig. 25 Location of survivors, who reported water on Deck 2 (Vehicle deck) above, but not on Deck 1.

- ⇒ The sudden heeling motion caused a momentary high water level on the port side of the center casing. This most likely contributed to water being able to flow down to the front compartments on Deck 1. This matches well with the testimonies of the survivors, who came up from Deck 1 just after the sudden heel and encountered water on the way up.

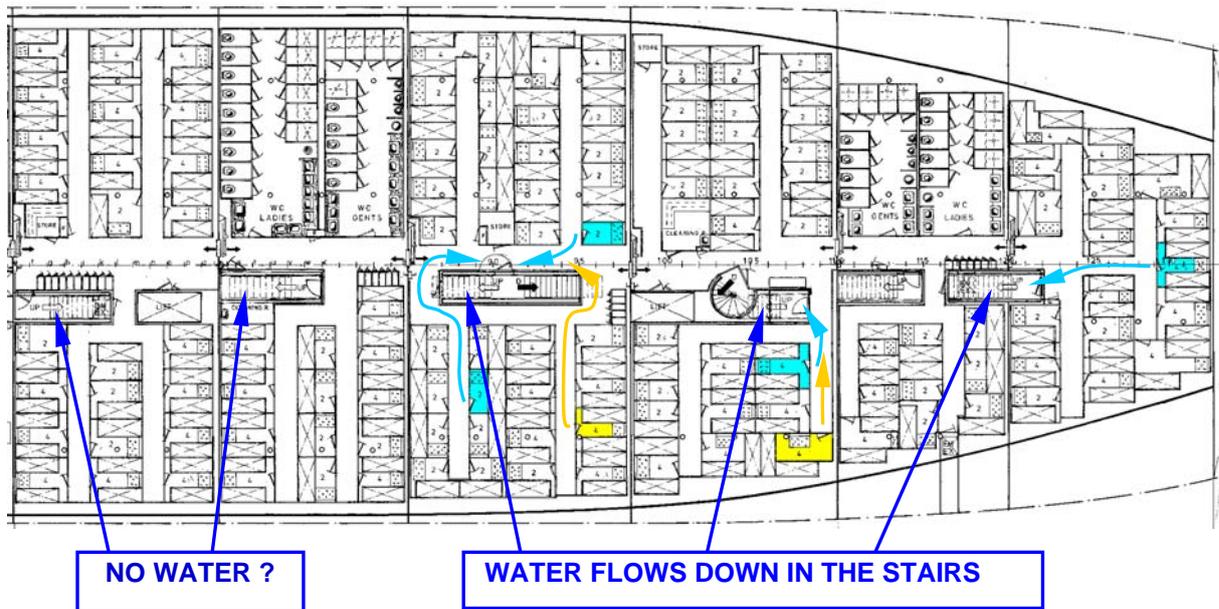
Fig. 26 Location of survivors, who reported water on Deck 1, and their likely escape routes. The two yellow cabins are alternative locations for one person escaping from Deck 1. The person had either the cabin number 1069 or 1096.

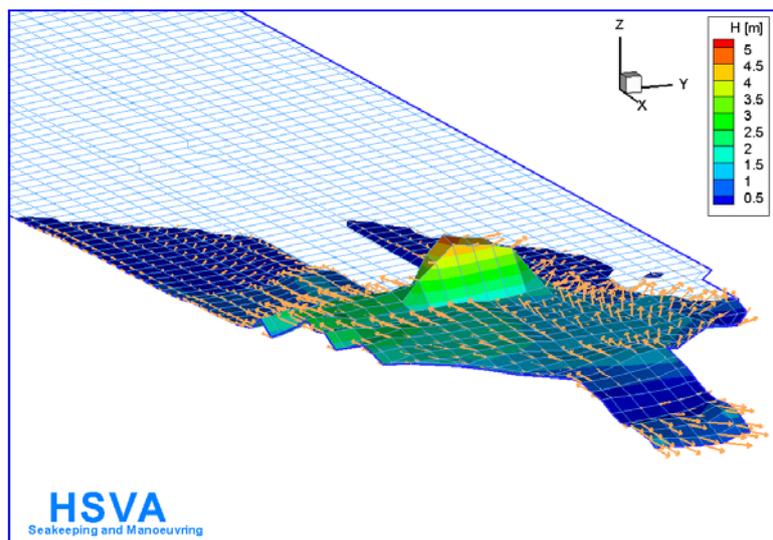
Fig. 27 Waves on the vehicle deck coming in through the open bow (fully open ramp) slosh against front face of the central casing and splash water high up. The colors show the water height and the vectors the flow direction and speed.

- ⇒ If the ramp was open, it is likely that incoming waves hit the front face of the center casing splashing water high towards the camera fixed on this face making the camera wet, as described by the crew members in the ECR. See Figure 27.
- ⇒ The flooding of the vehicle deck started from the bow. As the ship was rolling and pitching in the waves, it is likely that some water splashed or flooded into the staircases in the center casing and flowed further down into the front compartments on Deck 1 already at the early phases of the accident.

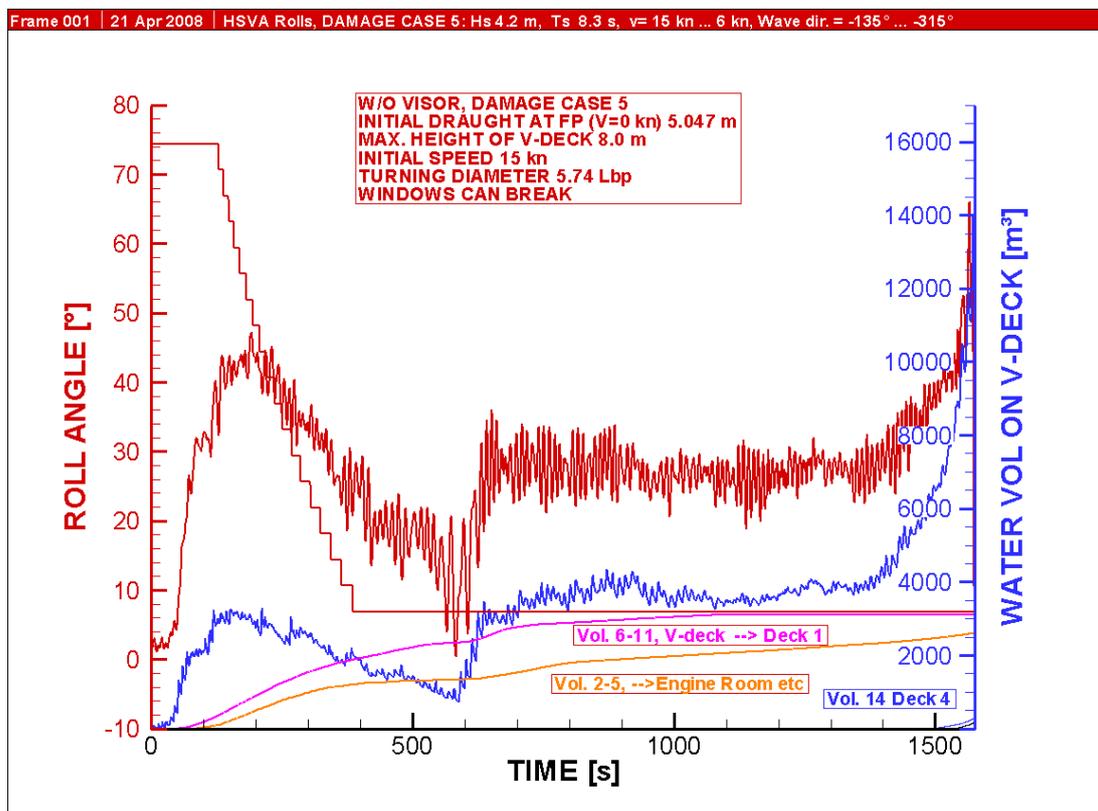
Fig. 28 The figure shows the heel angle and the real water volumes on the vehicle deck, on Deck 1 and on the machinery related spaces as a function time. The line consisting of the steps shows the change of ship relative course from -135° to -315° , that is, a turn of 180° .

1. The vessel capsizes early during the turn. This behavior is similar, but not identical to the capsize behavior of the *MV Herald of Free Enterprise*.
2. The vessel turns fast and reduces speed. This allows the vessel to survive the turn. Thus the vessel does not capsize instantly. After the turn the water sloshes gradually out of the vehicle deck, as the ship pitches in the waves.
3. The vessel barely survives the turn, but the heel remains large enough to bring the ventilation ducts at the ship side into water, which is critical. Water also flows from the vehicle deck through the center casing in to the passenger compartments on Deck 1. Later the windows on Decks 4-7 start to break. A slow further heeling and sinking takes place.

The Figure 28 shows an example of the simulated behavior of the *MV Estonia* of the type 3 above. The water volumes shown in Figure 28 are real water volumes. As the water distributes on the both sides of the center casing, the corresponding ship list is smaller, than a simple hydrostatic analysis would give for the given amount of water on the vehicle deck.

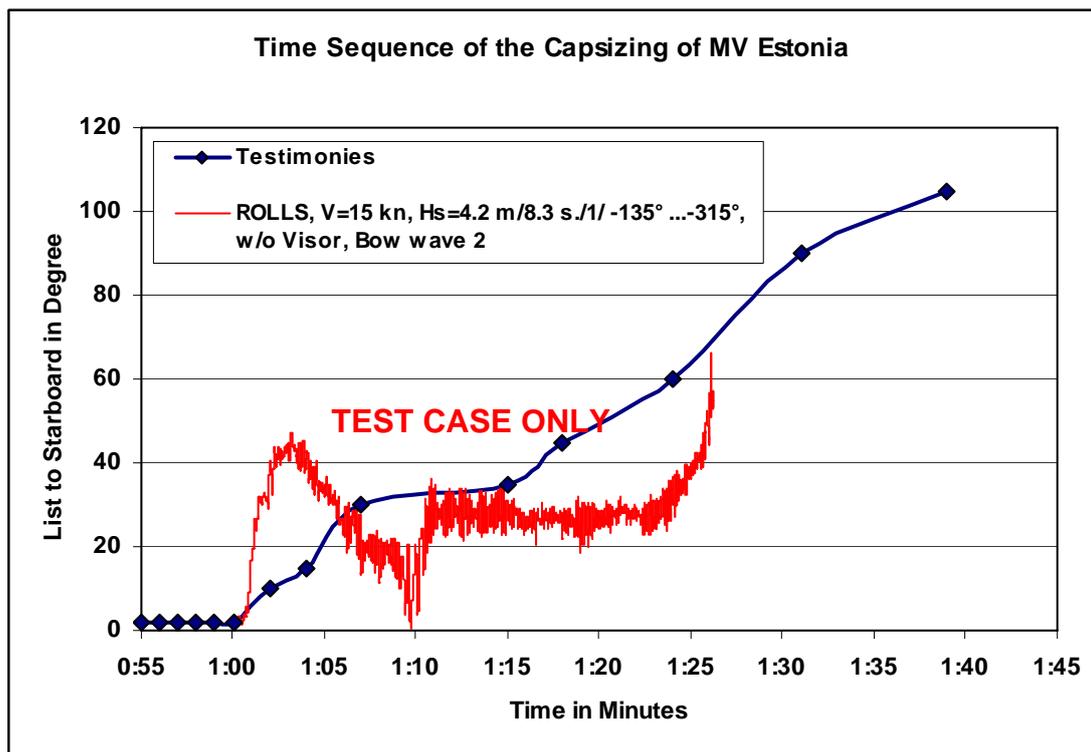
Fig. 29 The computed heel for the vessel together with the approximate list of the vessel according to the survivors' testimonies by TUHH.

The slowly increasing list according to the compilation of the survivors' testimonies by the TUHH, without the large sudden heeling, is shown in Figure 29 together with the computed curve. Both curves level off after the initial increase in the ship heel.

The computed roll behavior of the ship depends strongly on the random wave pattern used in the computations. Thus the computed curve in Figures 28 and 29 is just one example of many

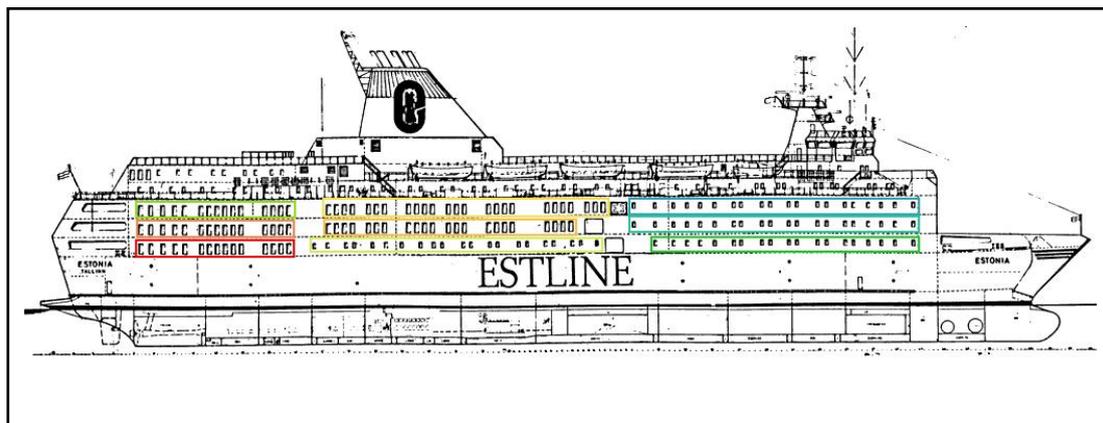
- Four large-window groups in the stern and middle on Decks 4-7 of the ship break before the first small-window group in the middle of Deck 4 breaks.
- All large-window groups in the stern and middle on Decks 4-7 of the ship break before the first small-window group in the bow of Deck 4 breaks.
- In this test case the windows do not break instantly, but take some time for the breaking process. The order at which the windows break according to the simulations contributes to the vessel sinking at stern first.

Fig. 30 The order the windows break in the simulations is shown with the colored rectangles: First red, next orange, then yellow and green and at last blue.

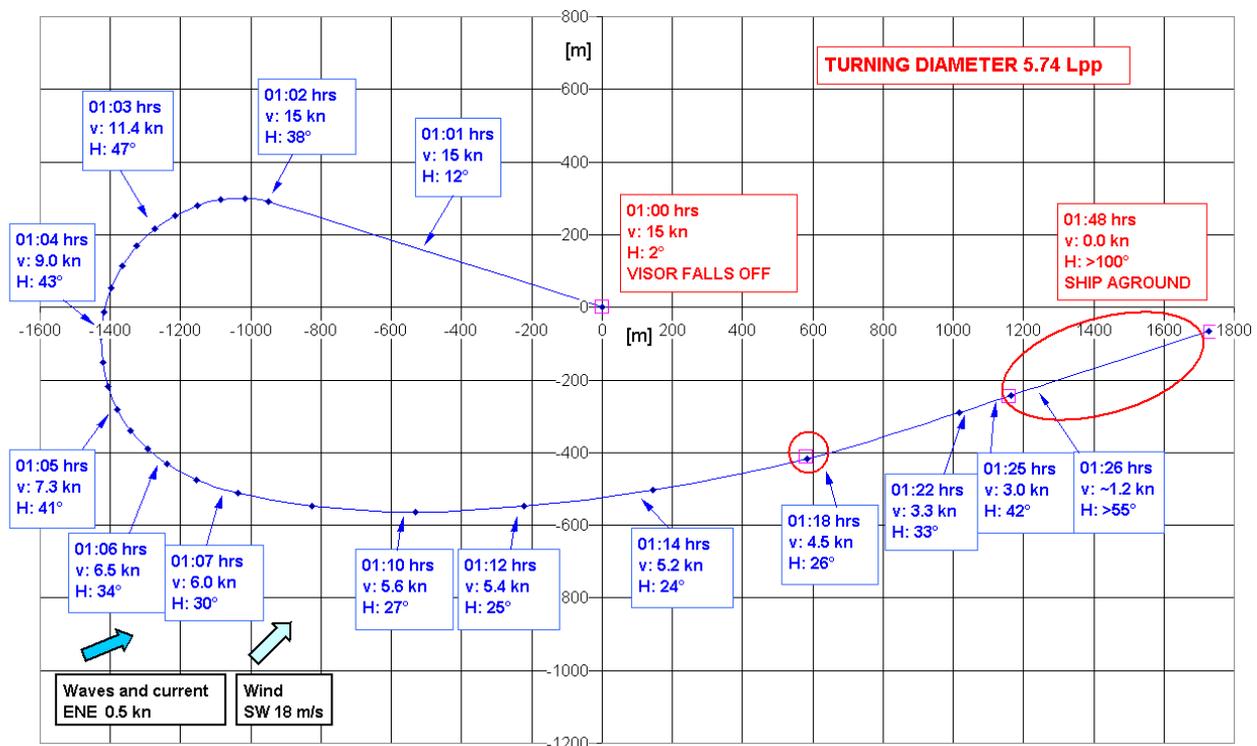
Fig. 31 Track of the vessel with the turning diameter of $5.74 L_{bp}$.

The symbols v and H in the figure indicate the ship speed and the heeling angle, respectively, at the times given. It is assumed that the visor drops and the ramp opens fully at 01:00. At

01:02 the vessel starts to turn. The turning diameter in this simulation is approximately 790 m. The vessel comes out of the turn at 01:07 having a speed of about 6 kn. At 01:18-01:22 the main engines have already stopped and the starboard list starts to increase towards 35°. A single large item has dropped from the ship to the sea bottom during this phase. The speed of the ship over the ground including the contribution from wind and current is assumed to be about 4 kn. At 01:26 the speed over the ground has reduced to about 1.2 kn and the ship list exceeds 55°. At this phase many loose items start to fall off from the decks of the heavily heeled vessel. These items distribute on the seabed along the track of the vessel as shown in Figures 3 and 31 with the red ellipse. Therefore it is likely that the ship did not capsize rapidly, but that the heeling continuously increased as the vessel was drifting. At this phase the vessel had a large list and draft. Thus the effect of wind on the ship should have been relatively small. The dominant forces driving the ship would have been waves and current. Towards the end of its track the ship moves very close to the direction of waves and current. The distance covered along the track shown in Figure 31 and on the other hand the assumed ship speeds and the indicated times in the same Figure 31 do agree. The assumed drifting speed of the vessel at the end of the track is based on available empirical data on ship drift.

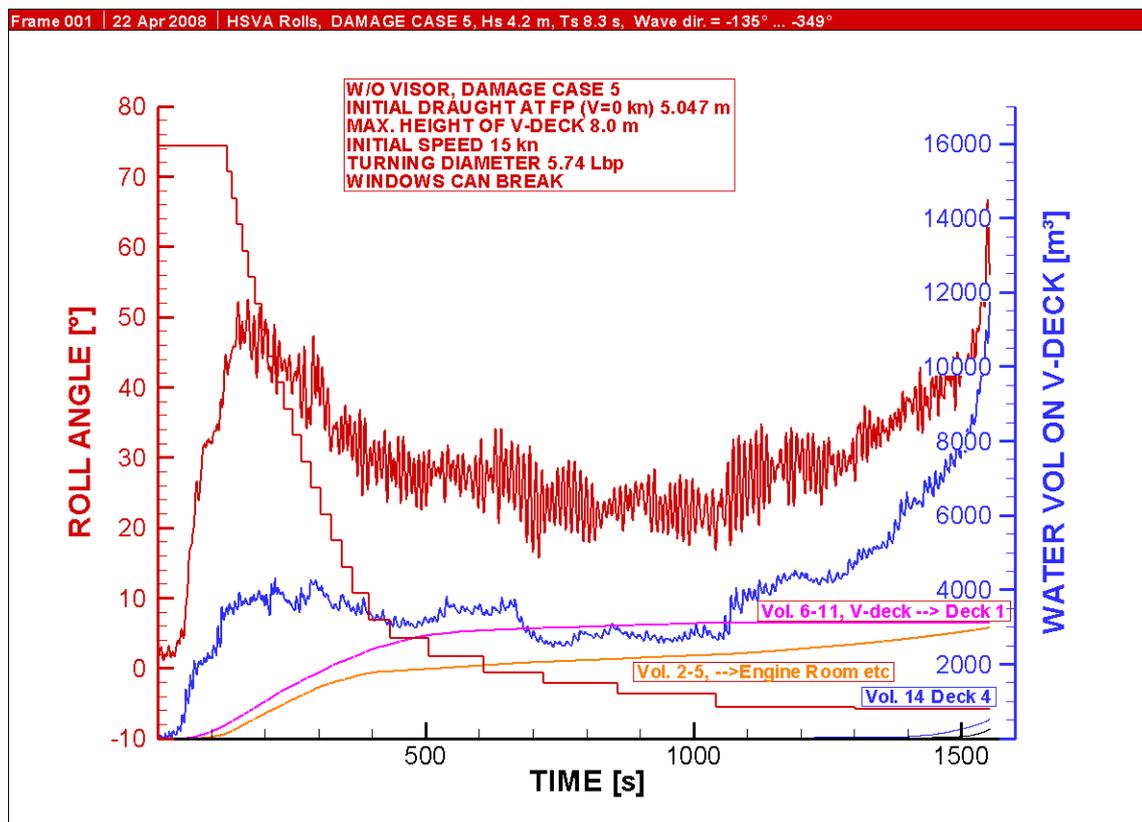
In these last mentioned cases the ship heels gradually over and starts to sink very often between 1000-2200 seconds (16-36 min) after the start of the simulation, that is, after the opening of the bow ramp. The heeling behavior shown in Figure 32 is typical to these cases. During the initial phase water flows onto the vehicle deck, the list increases and at the start of the turn the ship heels heavily to starboard. As the speed reduces during the turn the centrifugal acceleration decreases. Therefore the vessel rights itself somewhat. A significant list to starboard remains. As gradually more water flows into spaces below the vehicle deck, the draught increases and the amount of water on the vehicle deck and with it also the heeling angle increase again. At the end of the simulation this development is quite rapid. Altogether the simulation of the ship's progress along the given track gives a plausible flooding and heeling behavior fitting to most known facts on the accident. The track of the vessel corresponding to the computation (until 01:26) is shown in Figure 31.

Fig. 32 The heeling angle and the water volumes on the vehicle deck, on Deck 1 and on the machinery related spaces as a function of time. The curve consisting of steps shows the change in the ship relative course from -135° to -349° with respect to the wave direction.

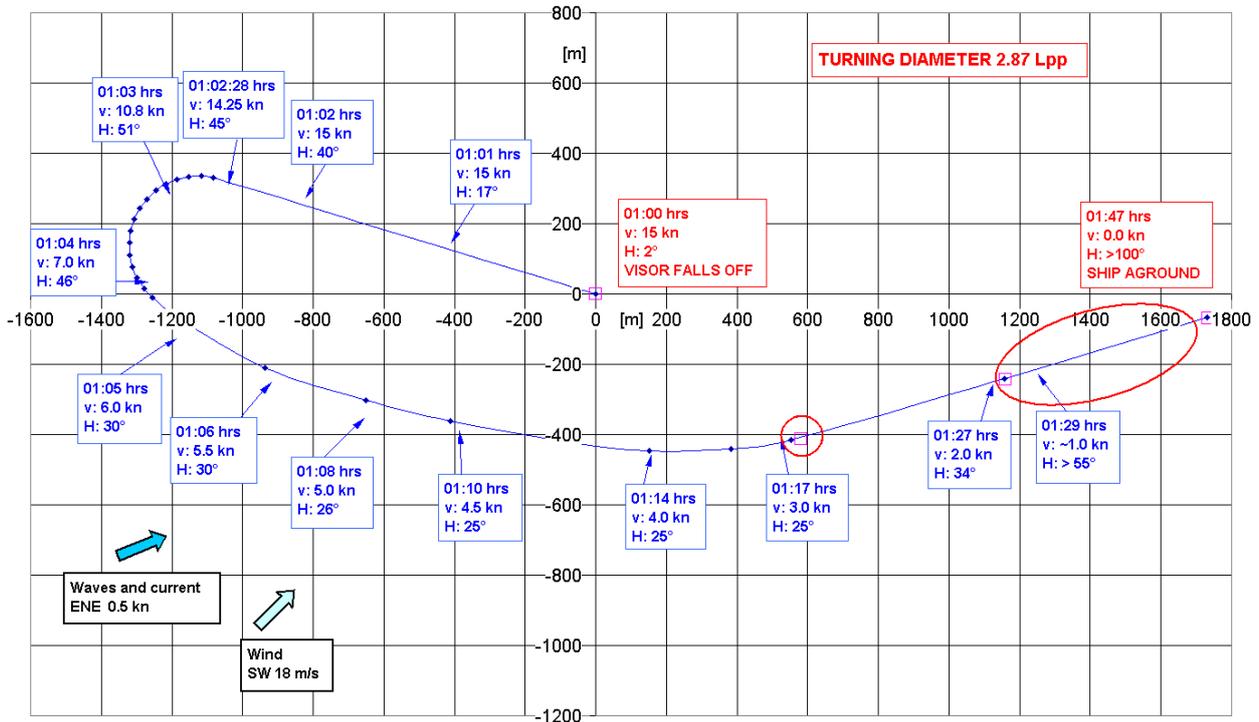
Fig. 33 Track of the vessel with the turning diameter of $2.87 L_{bp}$

The simulation shows that the vessel continued approximately two and a half minutes on a straight course assuming that the bow ramp was completely open. As the turning diameter is smaller ($2.87 L_{bp}$) the vessel turns faster away from the waves and its speed reduces faster than in the previous case having a larger turning diameter. Therefore the time before the ship has to start to turn, in order to avoid capsize, can in this case be a little longer than in the case with the larger turning diameter.

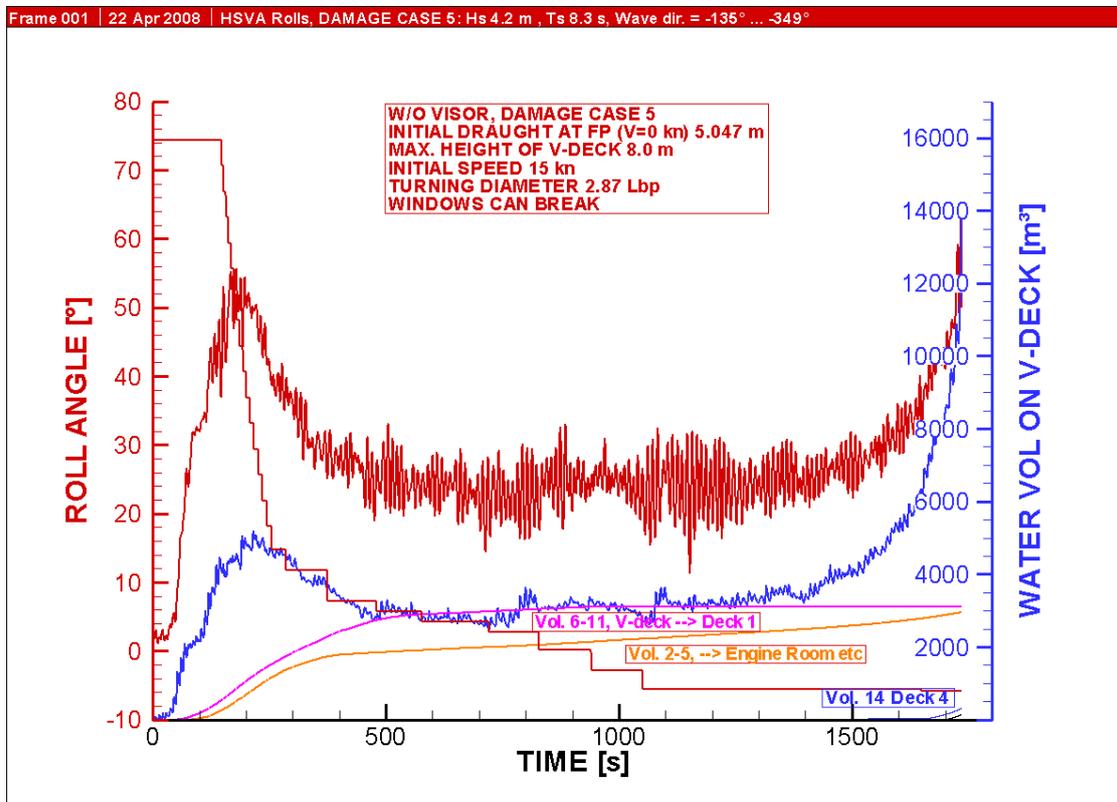
Fig. 34 The heeling angle and the water volumes on the vehicle deck, on Deck 1 and on the machinery related spaces as a function time. The line consisting of the steps shows the change of ship relative course from -135° to -349° .

A clearly shorter time is not likely as the vessel would in this case survive. Many simulations show that if the initial time before the start of the turn was about two and a half minutes, the vessel most likely survives the actual turn. The behavior is altogether similar to the one along the track with the larger turning diameter.
