HSVA Report No. 1663

**Research Study on the Sinking Sequence
and Evacuation of the *MV Estonia*
- Final Report**

Client: VINNOVA

Hamburg, May 05, 2008

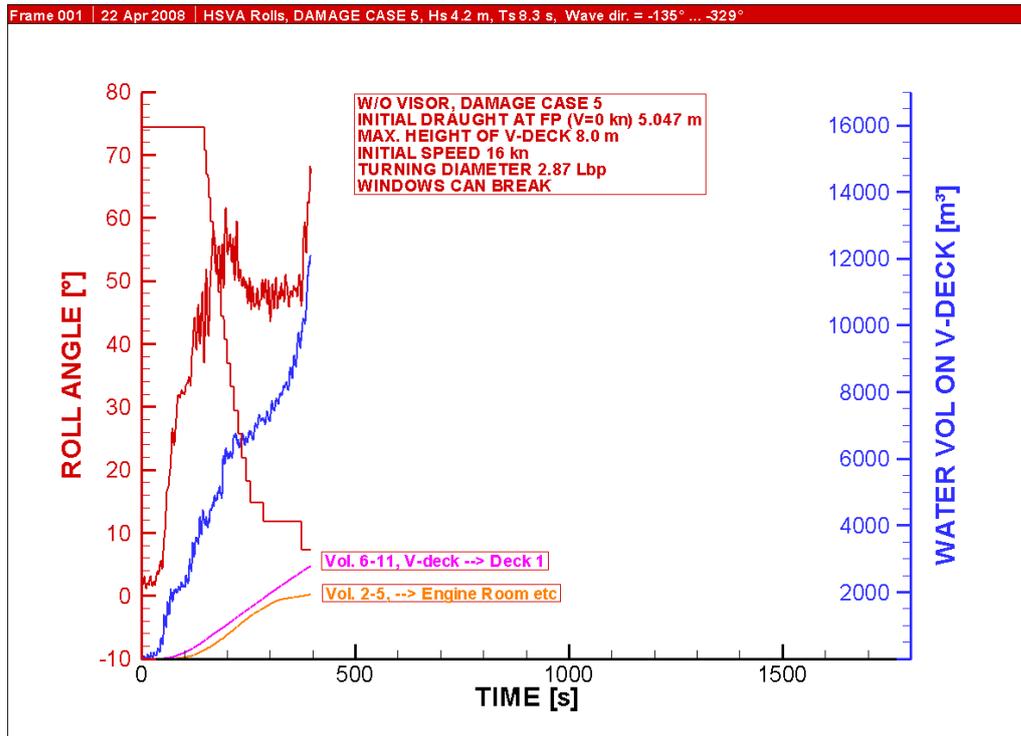
Fig. 35 The heeling angle and the water volumes on the vehicle deck, on Deck 1 and on the machinery related spaces as a function time. The ship speed is about 1 kn higher than in the previous Figure 34. The ship capsizes before it gets out of the turn.

The behavior of the ship is sensitive to the speed during the turn. Figure 35 shows a simulation with the ship speed elevated about 1 kn: The ship capsizes before it gets out of the turn. Figure 36 shows the ship behavior when the speed is about 0.5 kn slower in the original case shown in Figure 34. The ship survives the turn and the time thereafter: The water on the vehicle deck flows gradually out as the slowly advancing vessel is pitching in waves coming from the starboard stern quarter or stern. These three types of behavior shown in Figures 34-36 were described already in Chapter 2.7. The modeling of the effects of the ship speed on the water ingress are explained in Appendix 3.

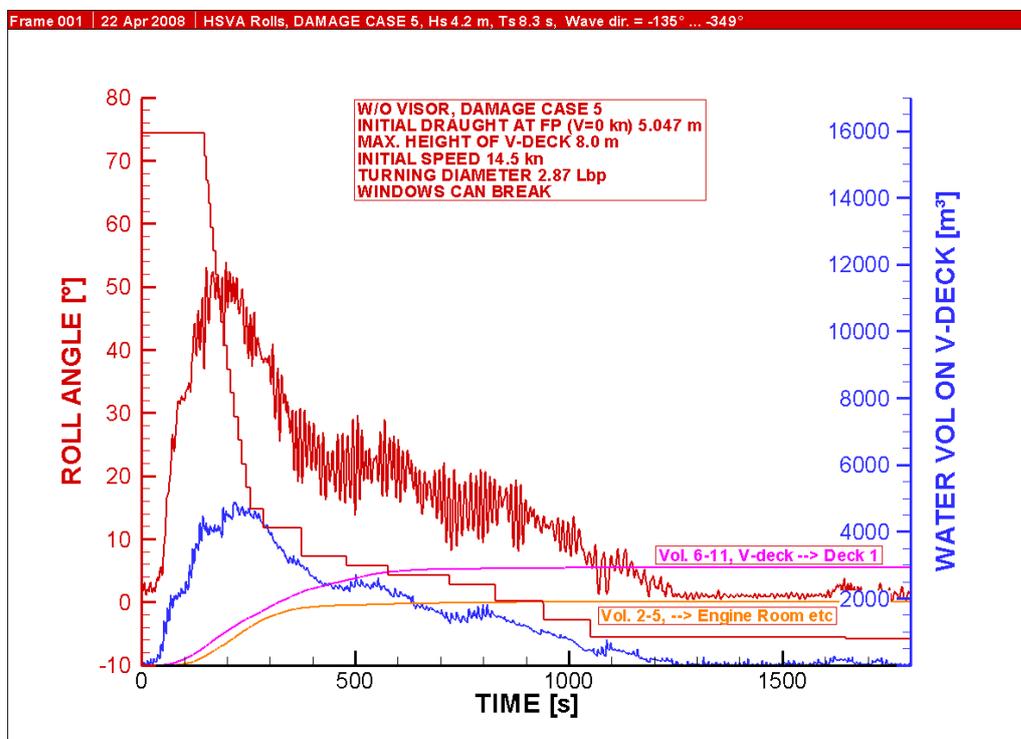
Fig. 36 The heeling angle and the water volumes on the vehicle deck, on Deck 1 and on the machinery related spaces as a function time. The ship speed is about 0.5 kn lower than in Figure 34. The ship survives the turn and the water flows out of the vehicle deck.

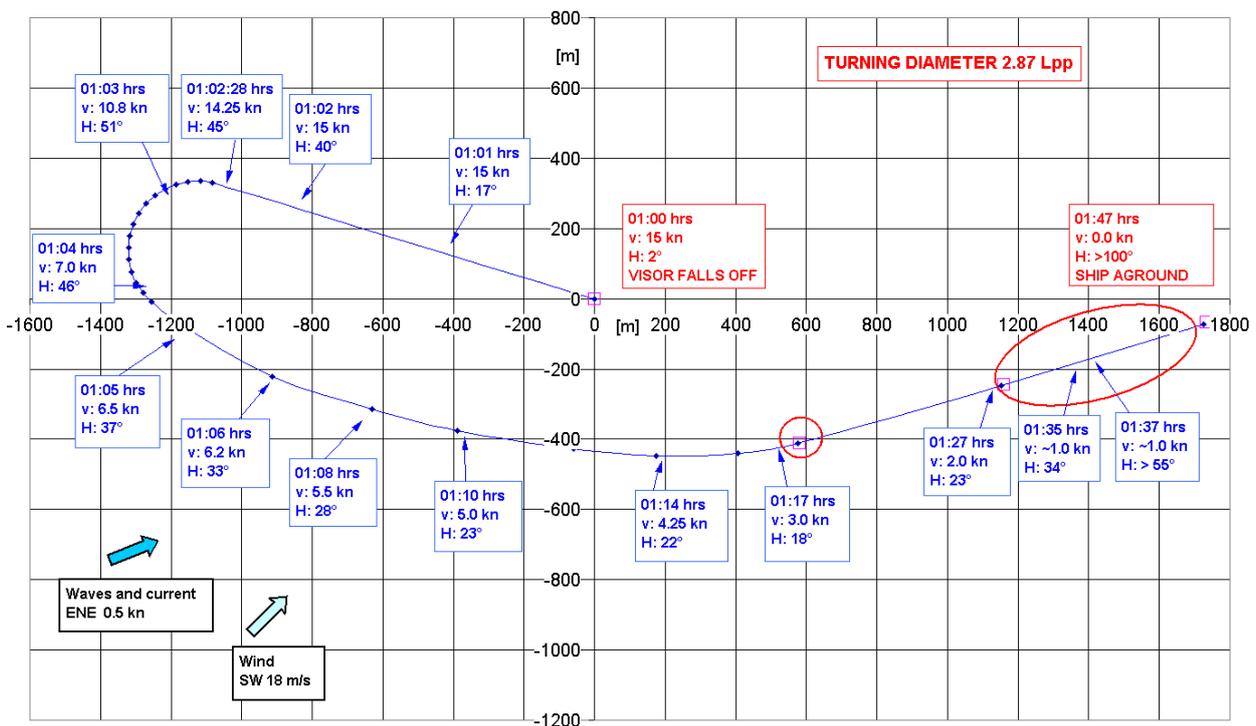
Fig. 37 Track of the vessel with the turning diameter of $2.87 L_{bp}$

Another almost identical track as in Figure 33 is shown in Figure 37. The only difference is made by the slightly higher speeds, when the ship comes out of the curve. The corresponding time-history of the roll angle of the vessel is shown in Figure 38. In this case the ship survives about 9 minutes longer than in the very similar case shown in Figure 34.

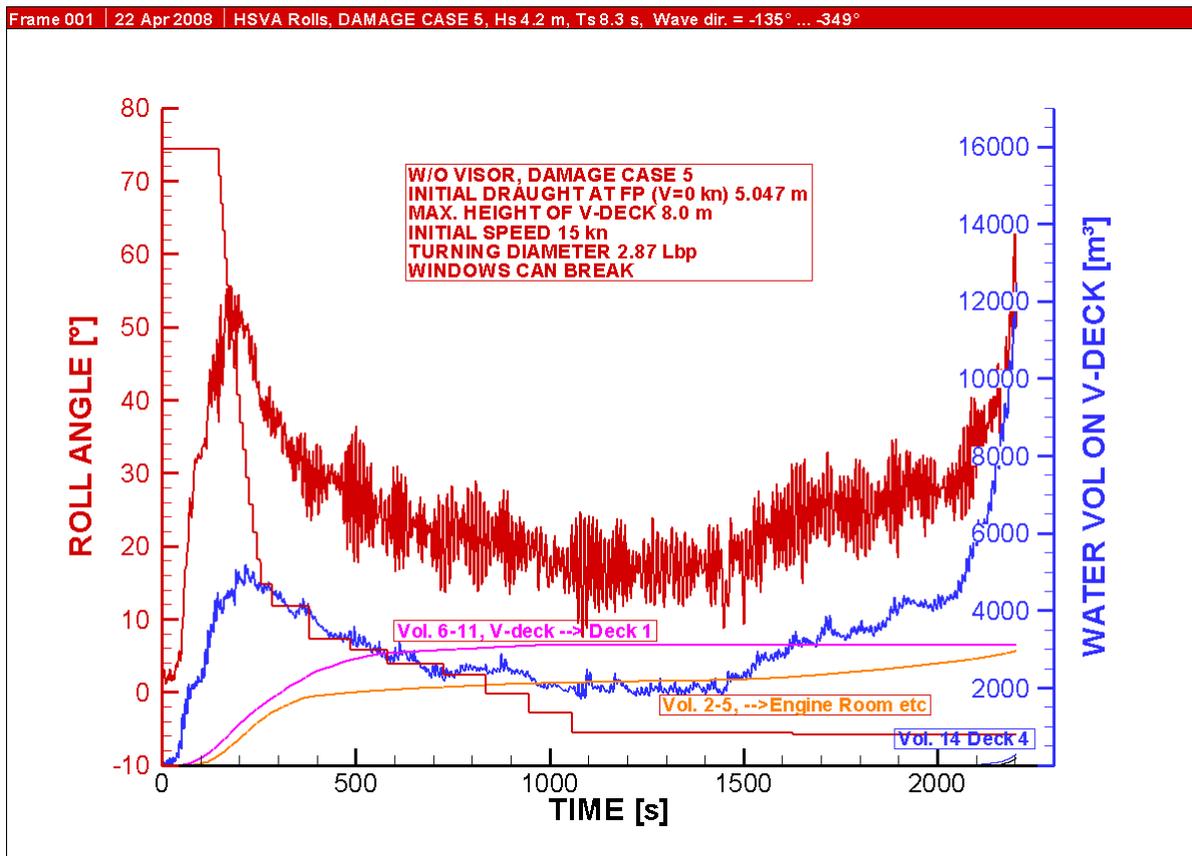
Fig. 38 The heeling angle and the water volumes on the vehicle deck, on Deck 1 and on the machinery related spaces as a function time. The line consisting of the steps shows the change in the ship relative course from -135° to -349° .

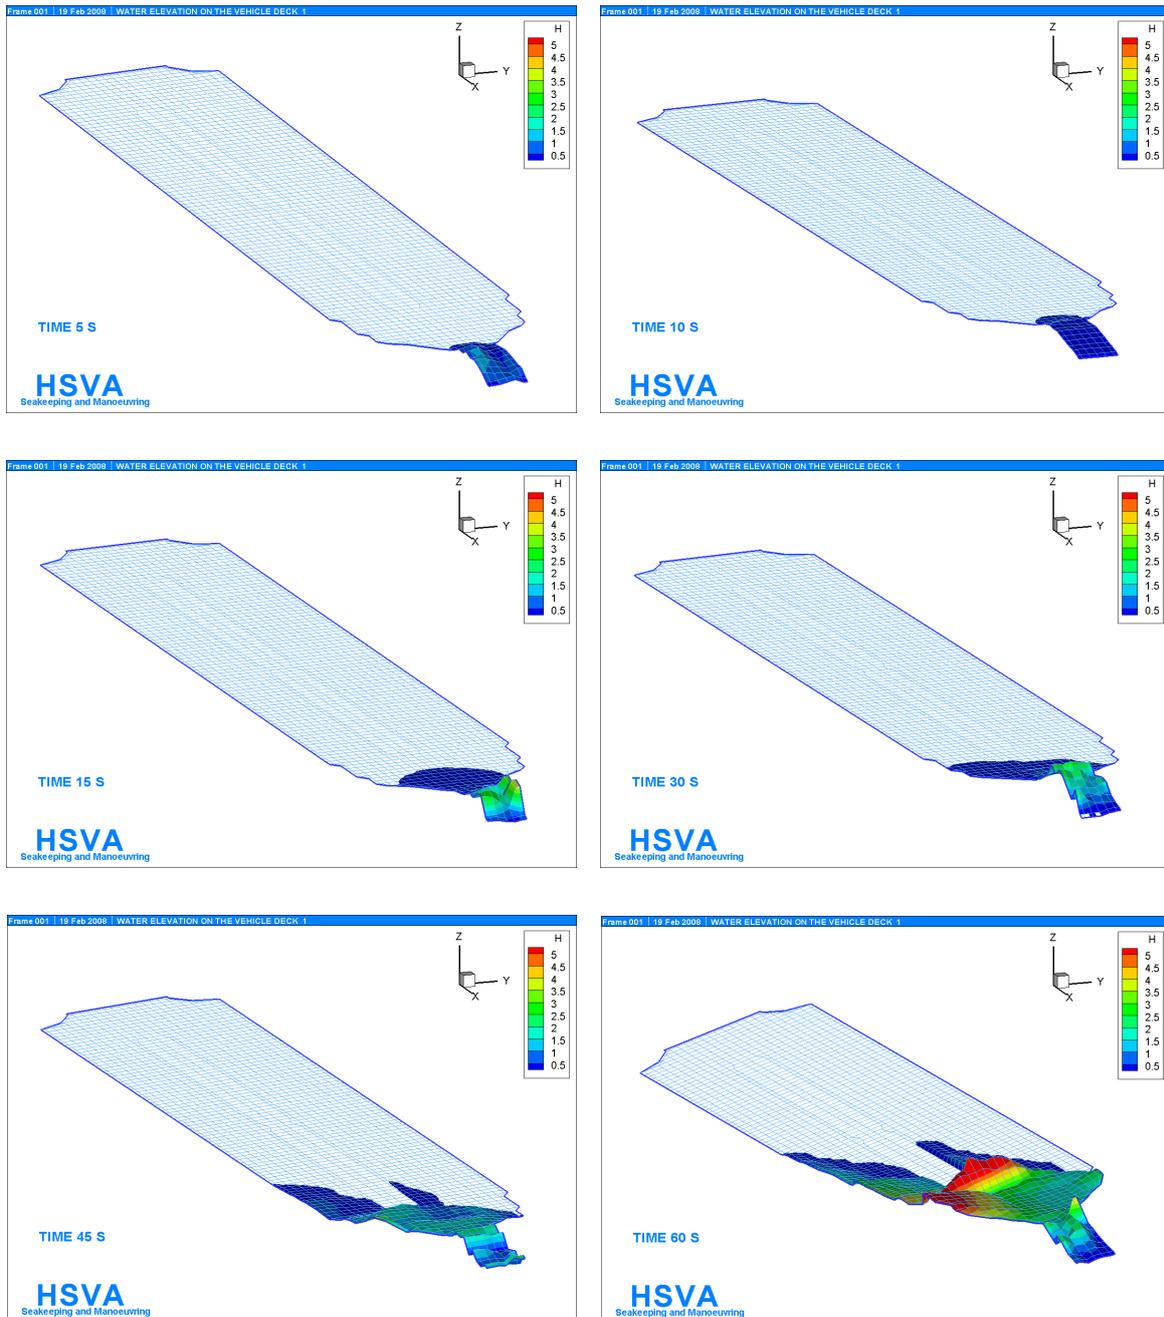
Figures 39a and 39b show screenshots of the flooding of the vehicle deck at different moments of time during the simulation corresponding to the case of the smaller turning diameter shown in Figures 33-34. It can be seen how the incoming water sloshes high against the front face of the center casing and flows onto both sides of the center casing starting from the bow.

Fig. 39a Screenshots of the vehicle deck flooding according to the simulation with HSVA ROLLS at times 5,10 ,15, 30, 45, and 60s. The coloring expresses the water height on the deck perpendicular to the deck. Due to the inflow speed at the open ramp the water flows onto both side of the center casing.

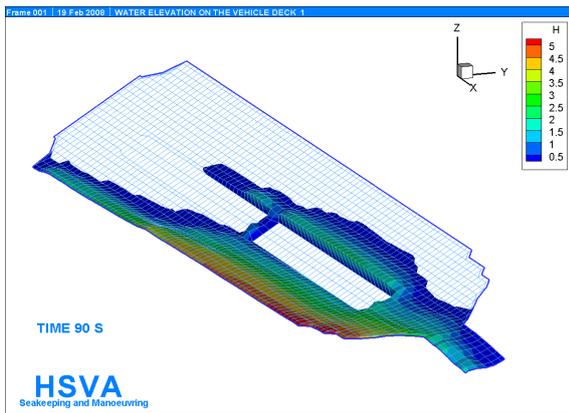
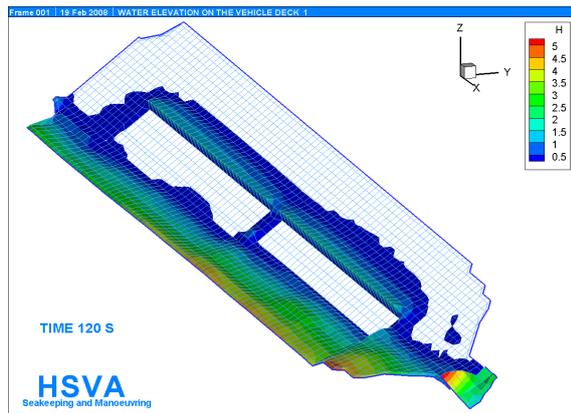
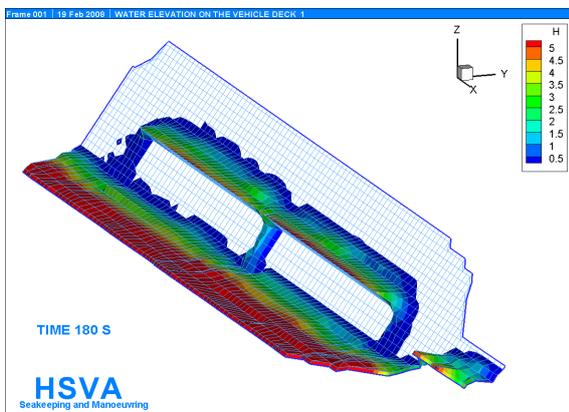
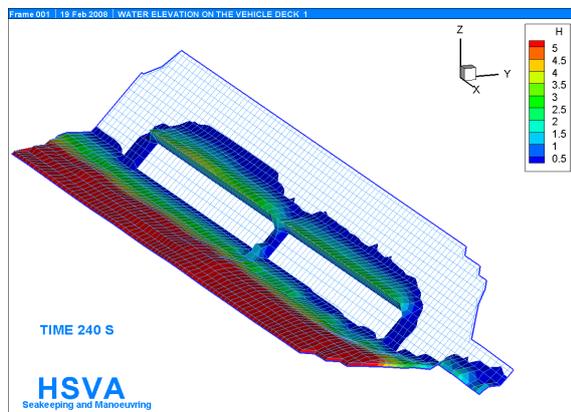
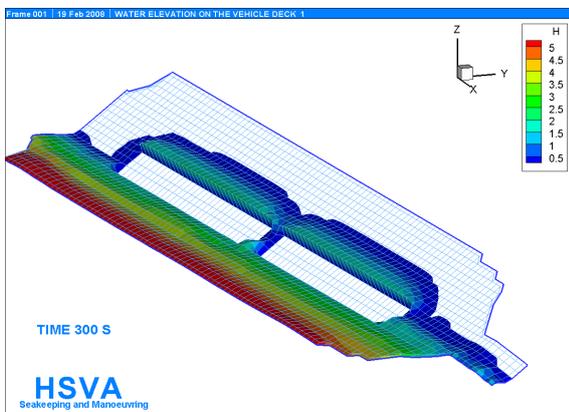
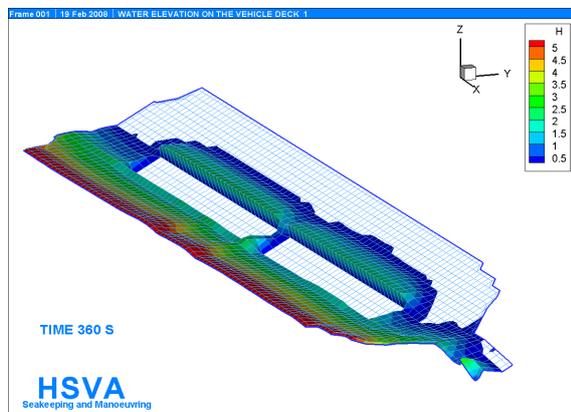
Fig. 39b Screenshots of the vehicle deck flooding according to the simulation with HSVA ROLLS at times 90, 120, 180, 240, 300, 360 and 400 s. The coloring expresses the water height on the deck perpendicular to the deck.

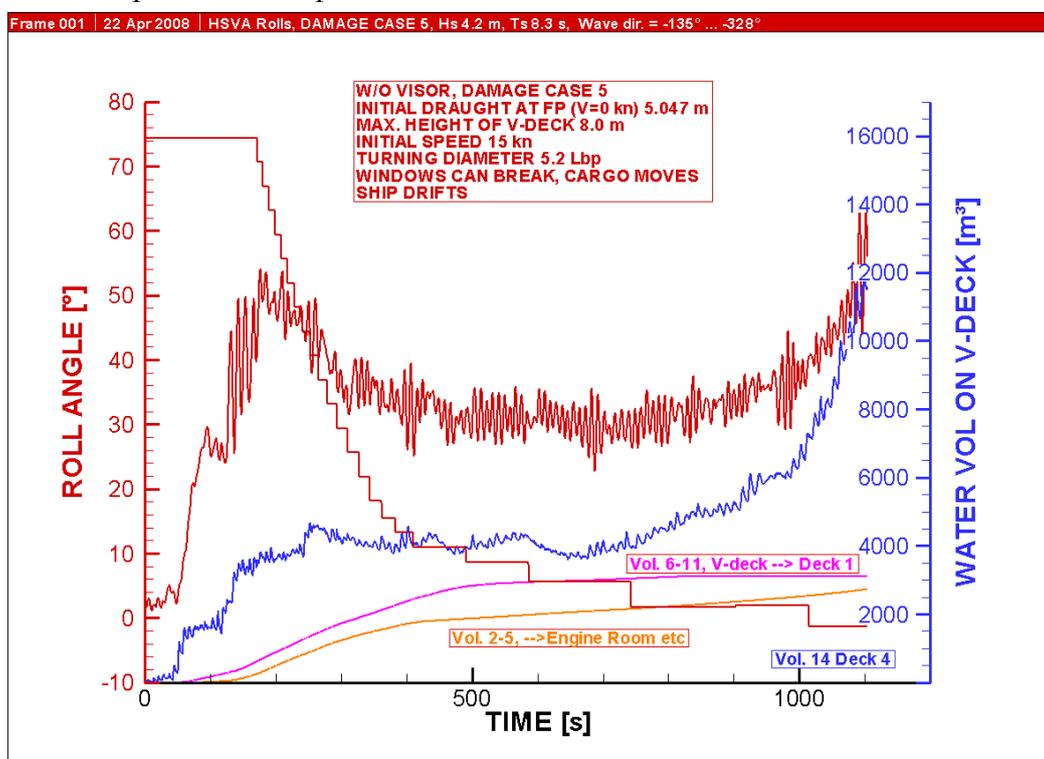
Fig. 40 The heeling angle and the water volumes on the vehicle deck, on Deck 1 and on the machinery related spaces as a function time. The shift of cargo and ship drifting are included in the simulation. The initial speed is 15 kn.

Figures 40 and 41 present one of the cases with initial speed 15 kn. Figure 42 shows the time history of heel for the case with lower initial speed of 14.4 kn. The track of the vessel for the latter is not shown, but does not essentially deviate from the one for the higher speed shown in Figure 41.

The computed curves correlate quite well with the empirical HSVA-curve until about 01:18 when the computed curves indicate rapid increase of heel and the applied numerical modeling gets out of the area, where the underlying assumptions are still valid. The computed first peaks are little higher and possibly also broader than the empirical curve based on the survivors' testimonies. This is to be expected as the numerically modeled vehicle deck is free of vehicles. Thus the water on the numerical vehicle deck can slosh completely freely, whereas in reality the sloshing was dampened by the presence of cars and trucks on the vehicle deck.

After the first sudden heel the computed curves level off. This can take place approximately at heeling angle levels 20°-35°. If the ship speed, turning radius and ship direction are adjusted so that the heeling level drops lower, the ship survives an unlimited time. If the parameters are adjusted so that the heeling angle would be higher, the ship heels over rather rapidly. Thus there are quite clear limits to the level at the which heeling angle after the initial sudden heel levels off.

At the black vertical line in Figure 40 the ship has turned 90° and the waves come from the starboard bow quarter and somewhat later from the starboard beam. Now with lower speed the water ingress is relatively small.

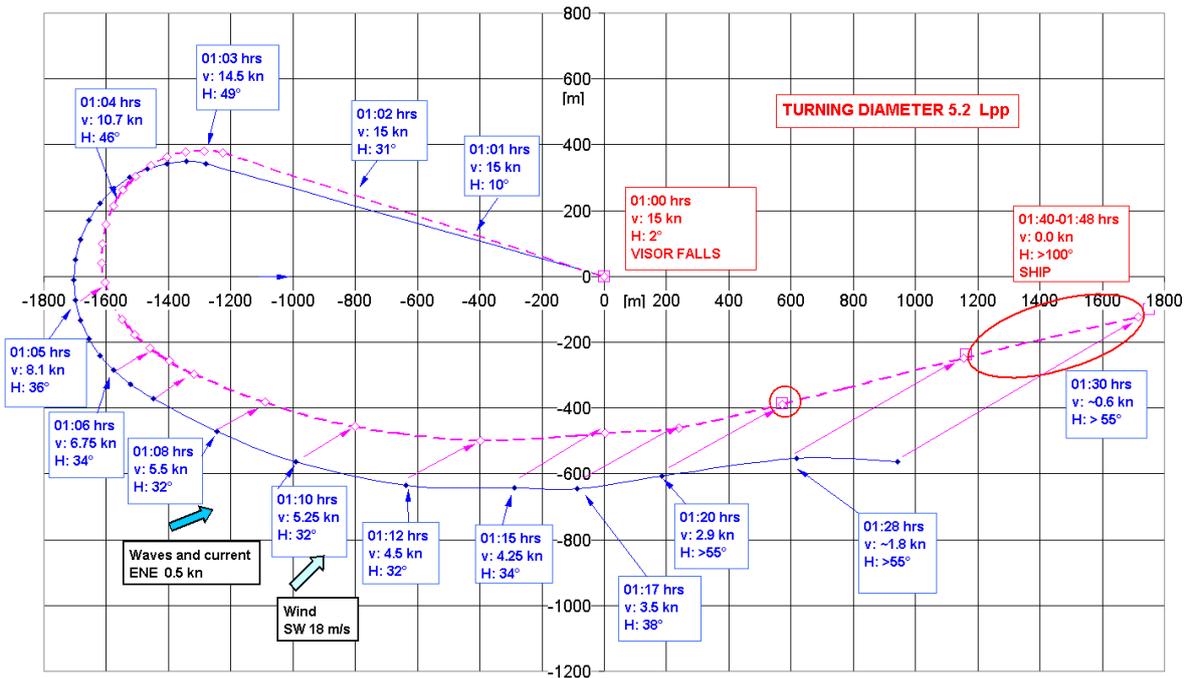
Fig. 41 Track of the vessel. The ship drift due to wind, waves and current is shown.

The corresponding tracks of the vessel fit to the time frame of the accident and to the positions of the visor, the debris from the ship and the wreck on the sea bottom. The corresponding computed flooding of the vehicle deck appears plausible and is in part supported by the testimonies of the survivors.

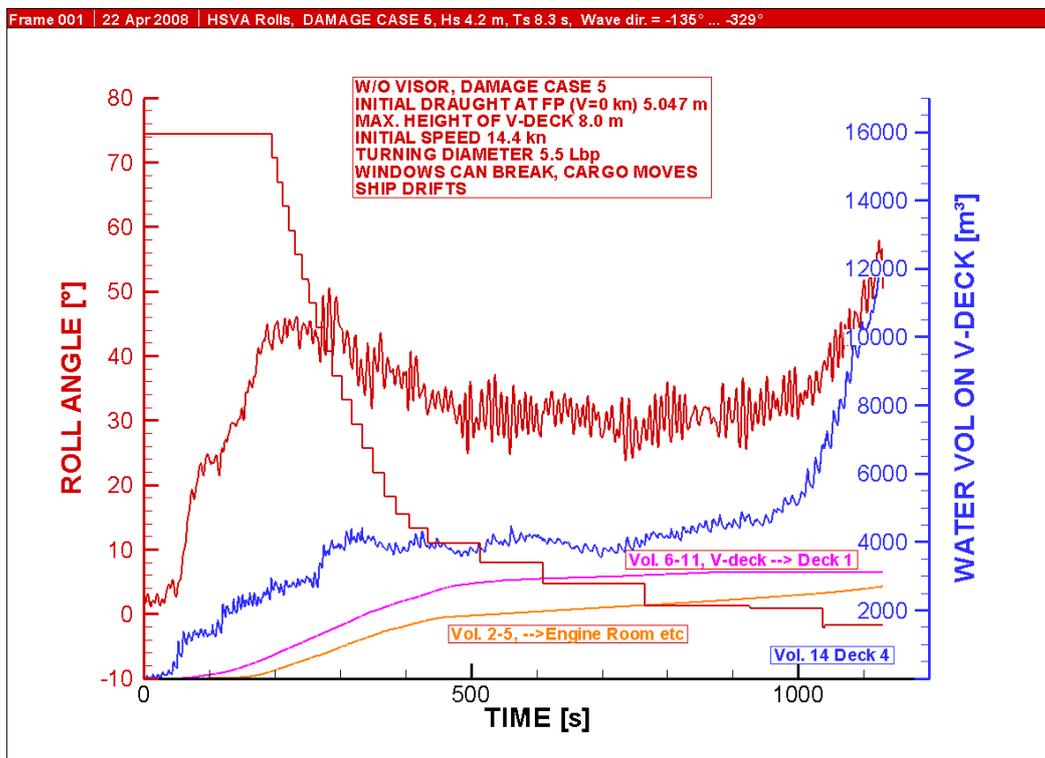
Fig. 42 The heeling angle and the water volumes on the vehicle deck, on Deck 1 and on the machinery related spaces as a function time. The shift of cargo and ship drifting are included in the simulation. Initial speed 14.4 kn.

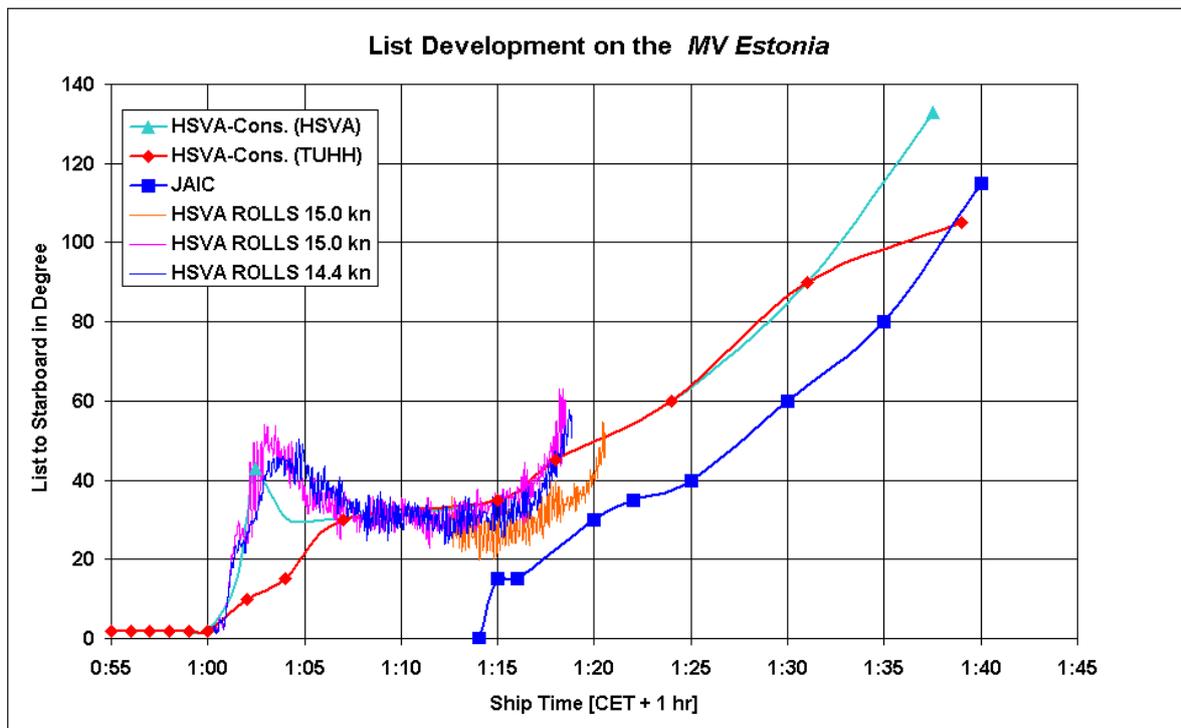
Figure 43 shows the three computed time-histories of the ship heel together with three curves showing the development of the ship's list as a function of time based on the survivors' testimonies. The lowest one is the JAIC-curve, the two upper curves are the HSVA- and the TUHH-curves. The difference between these two latter ones is that in the HSVA-curve the sudden large heel in the very beginning of the time-history is included. In addition the HSVA-curve rises somewhat steeper at the very end.

Fig. 43 Development of list to starboard during the *MV Estonia* accident.

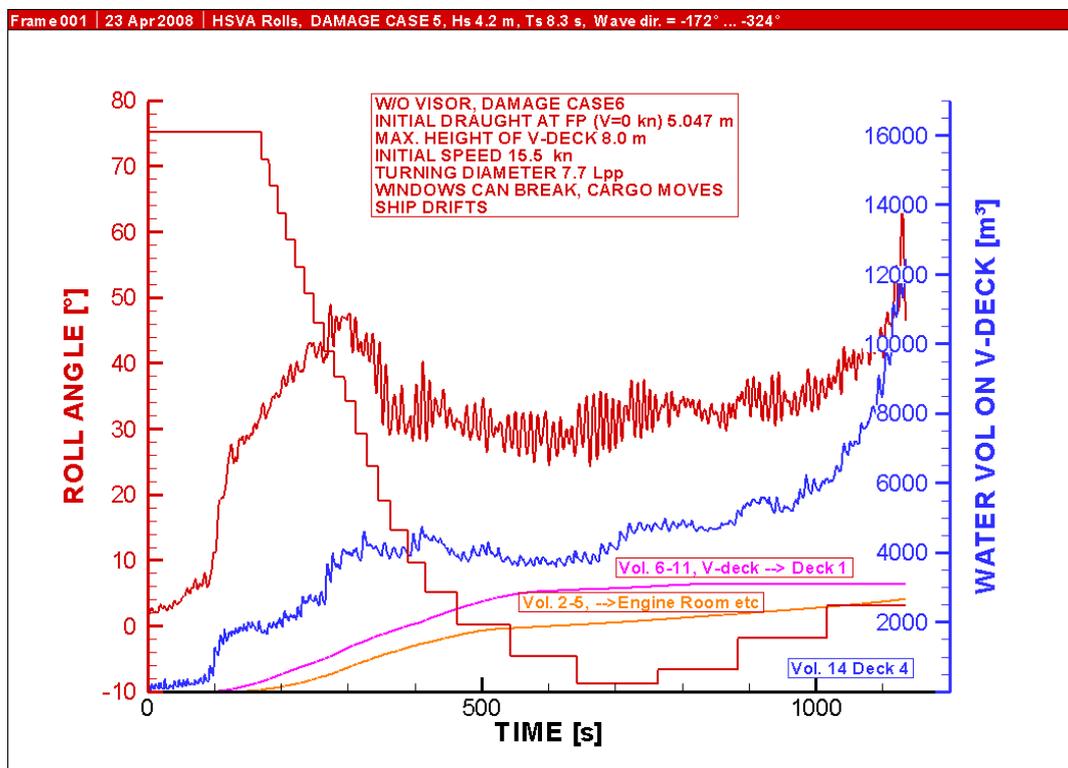
Fig. 44 The heeling angle and the water volumes on the vehicle deck, on Deck 1 and on the machinery related spaces as a function time. The shift of cargo and ship drifting are included in the simulation. Initial speed 15.5 kn. The initial course of the ship is 255°.

approximately towards west or west-southwest. For this reason one case with the initial course of 255° was computed. The results are illustrated in Figures 44 and 45.

With this initial course the ship needs a higher speed of 15.5 kn for about three minutes on the straight track and thereafter a relatively large to turn also with relatively high speed for the water ingress on the vehicle deck to be sufficient to cause a high heeling angle. Even though the initial speed is higher than in the previous cases the development of the first sudden heel takes longer, about 4-5 minutes. This does not correspond very well with the descriptions by the survivors.

From the point of view of the simulated results this scenario with an initial course of 255° would be possible, but less likely than the case with the initial ship course of 287° . There is, however, no reason to assume that the ship initial course deviated essentially from the mentioned 287° .

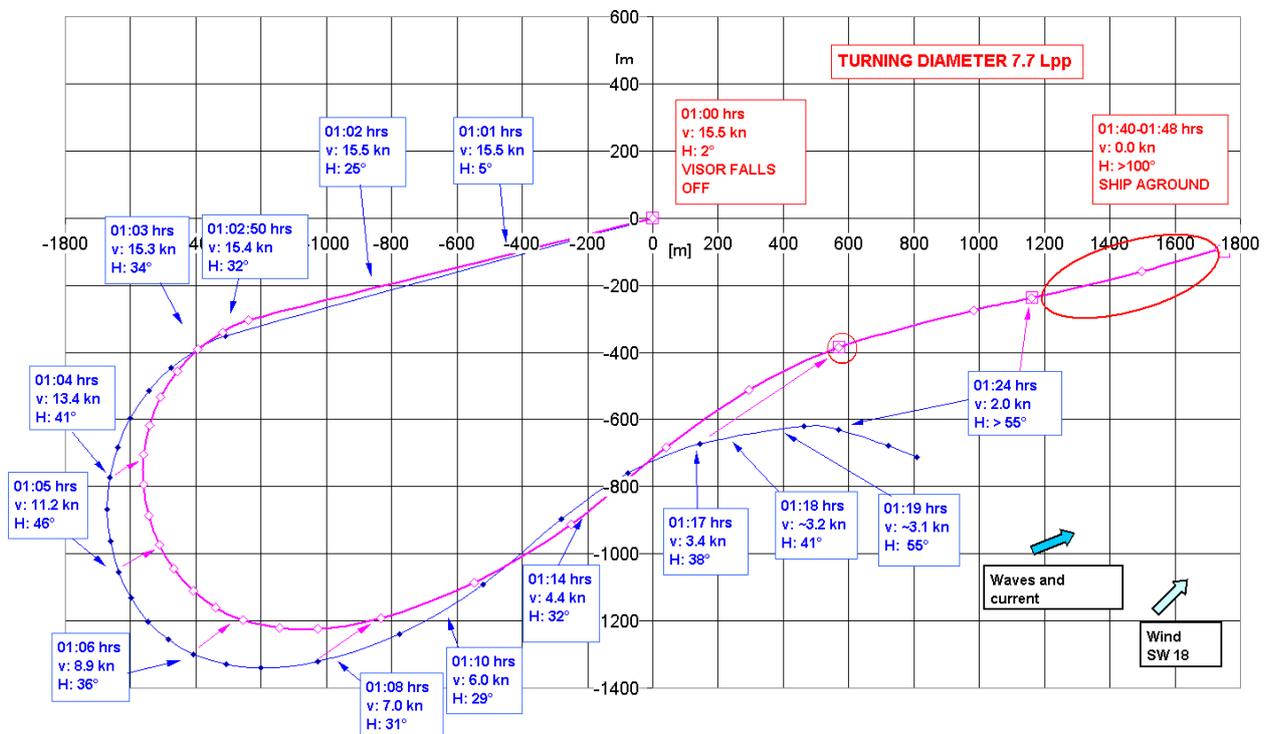
Fig. 45 Track of the vessel. Also the ship drift due to wind, waves and current is shown.

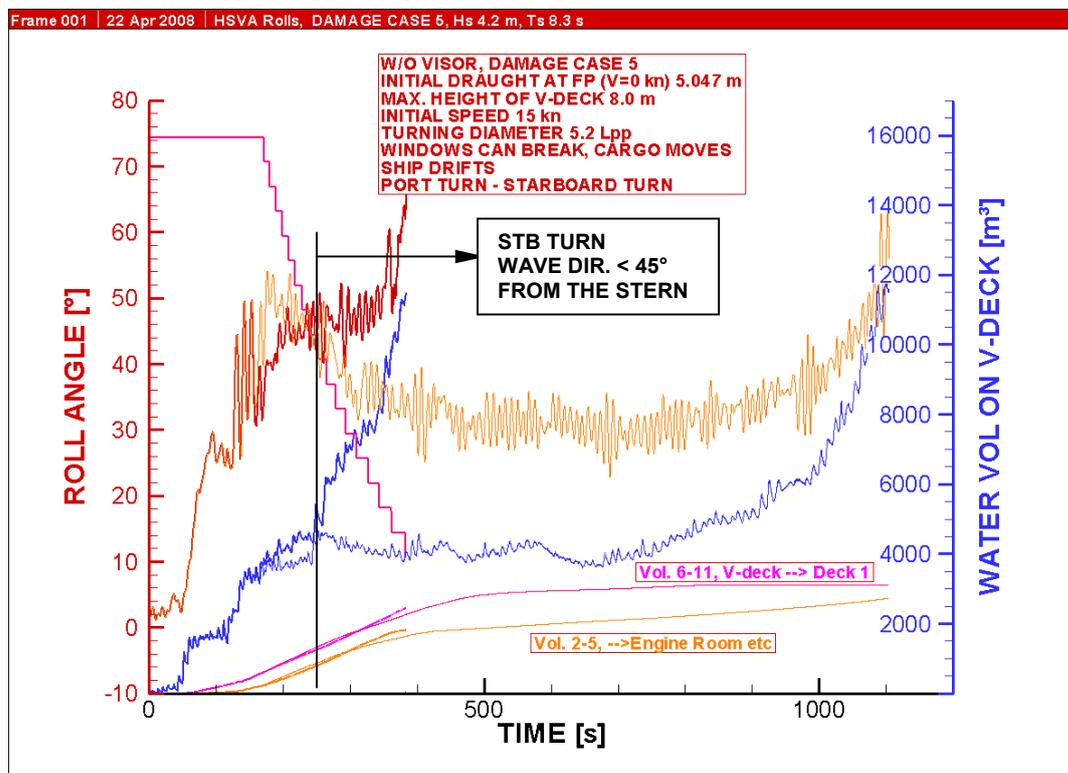
Fig. 46 The heeling angle and the water volumes on the vehicle deck, on Deck 1 and on the machinery related spaces as a function time. The shift of cargo and ship drifting are included in the simulation. Initial speed is 15.0 kn. The shorter curves show the behavior when the ship turns to starboard, the finer and longer curves show the behavior when it turns to port. Each step in the additional curve describes a 10° change in the ship's course.

The time-history of heel is shown in Figure 46 with the stronger curve when the ship turns to starboard, and with the finer and longer curve when the ship turns to port. During the turn to starboard the ship capsizes relative rapidly after a massive inflow of water onto the vehicle deck. The result may appear surprising, but on the other hand relatively little is known of the behavior of a damaged passenger car ferry in seaway with an open bow and water on the vehicle deck.

port bow quarter (45 ° from bow, 135° from stern). See the track of the vessel in Figure 41. In both cases the cargo shift takes place towards starboard. The vertical black line in Figure 46 shows the point at which the ship has turned 90° from its original course. At this point the waves come for the starboard turn from the port stern quarter and for the turn to port from the starboard bow quarter, as shown in Figure 41.

The centrifugal acceleration has a tendency to increase the heeling angle, which can be seen in Figure 46 just after the ship has started to turn. Notice that the associated water ingress is slightly lower than when the ship turns to starboard.

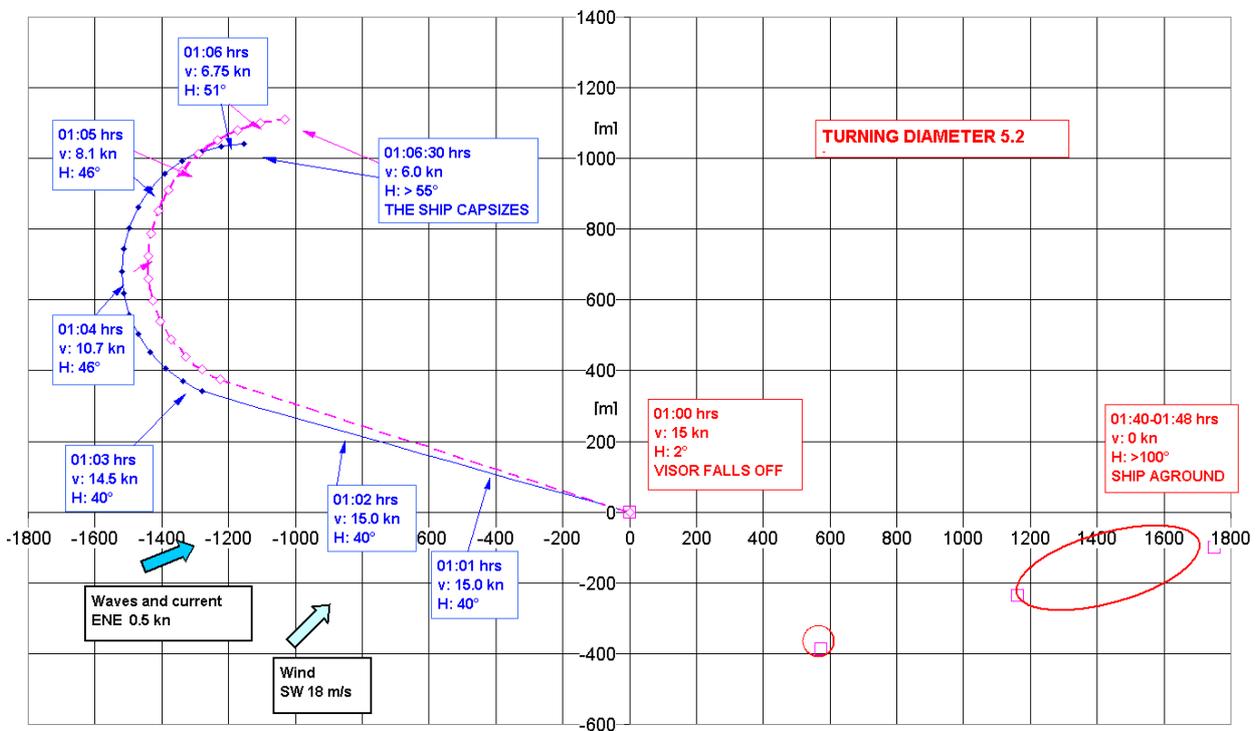
Fig. 47 Track of the vessel. Also the ship drift due to wind, waves and current is shown.

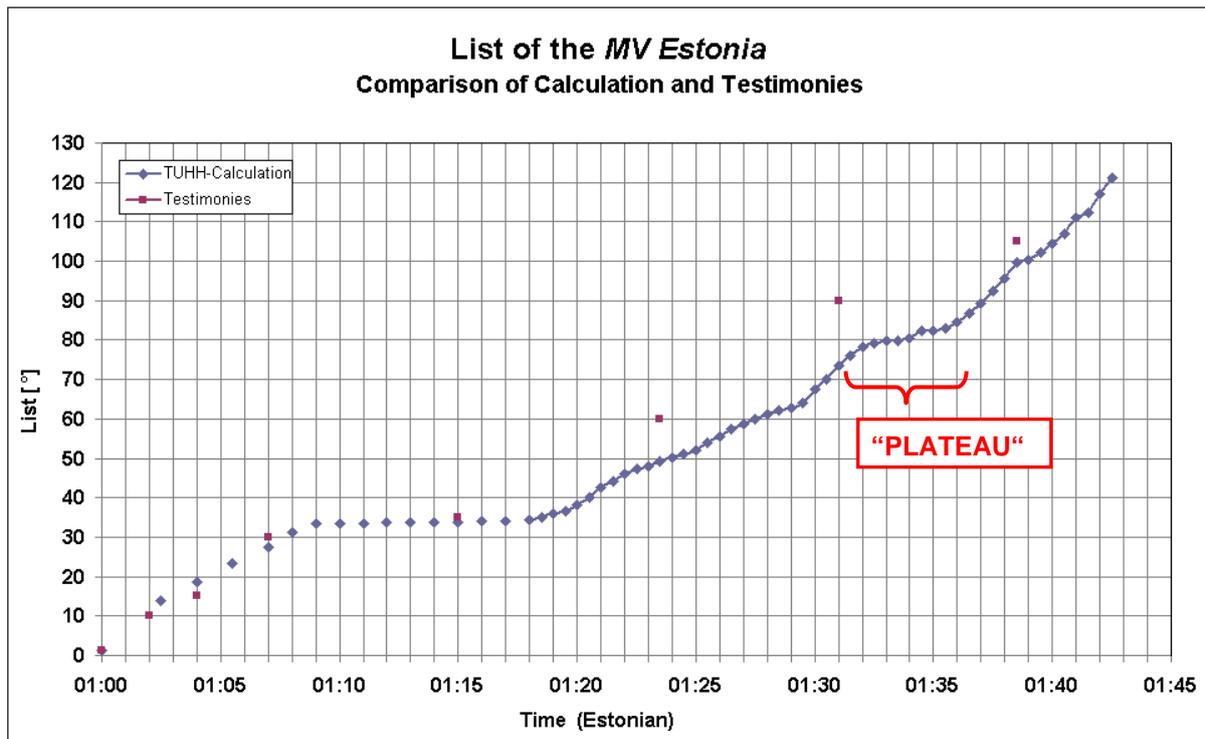
Fig. 48 Comparison of the development of list according to hydrostatic calculations by TUHH and survivors' testimonies.

It is worth noticing that many survivors report of walking on the port side shell plating of the *MV Estonia*. The time corridor of the heeling angle being approximately between 80° to 100° , in which walking on the vessel's side is likely to be possible, lasted about 6 or 7 minutes, as shown in Figure 48. This particular part of the curve is indicated with the sign "plateau" in Figure 48. This time is long in comparison with the relatively short overall sinking time, and is most likely an explanation for the many observations by the survivors during this period.

The development of the ship's list over time as computed by the TUHH is roughly in line with the testimonies of the survivors, as shown in Figure 48. This physically plausible sinking scenario suggests that the real sinking took place more or less or like the TUHH calculations show. It was further found that during all calculation steps the individual equilibrium floating conditions were stable. This means that the vessel would have floated for a long time at any of these equilibrium floating positions in case the water ingress would have been stopped. As a consequence it can be stated that the vessel did not capsize rapidly or turn upside down, a fact which is also in good agreement with the position of the vessel on the ground.

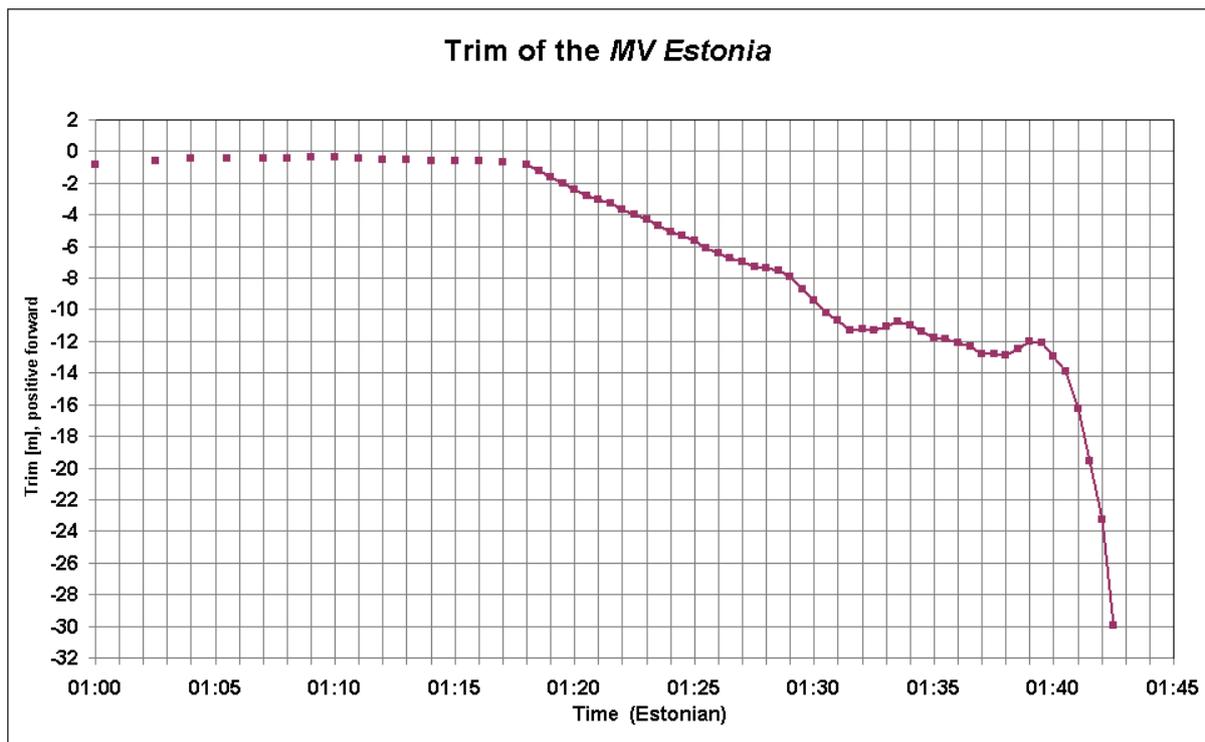
Fig. 49 Development of trim according to hydrostatic calculations by TUHH.

The increase in the trim slowed down, as more and more of the forward compartments began to flood. This can be seen in Figure 49. From 01:39 onwards the trim increased rapidly until 01:43, when the the stern of the vessel hit the sea bed. The *MV Estonia* sank stern first at a list of more than 120° to starboard and consequently hit the seabed with the top of Deck 9 first. This is an explanation for both, (1) the completely intact port side of the stern of the vessel,

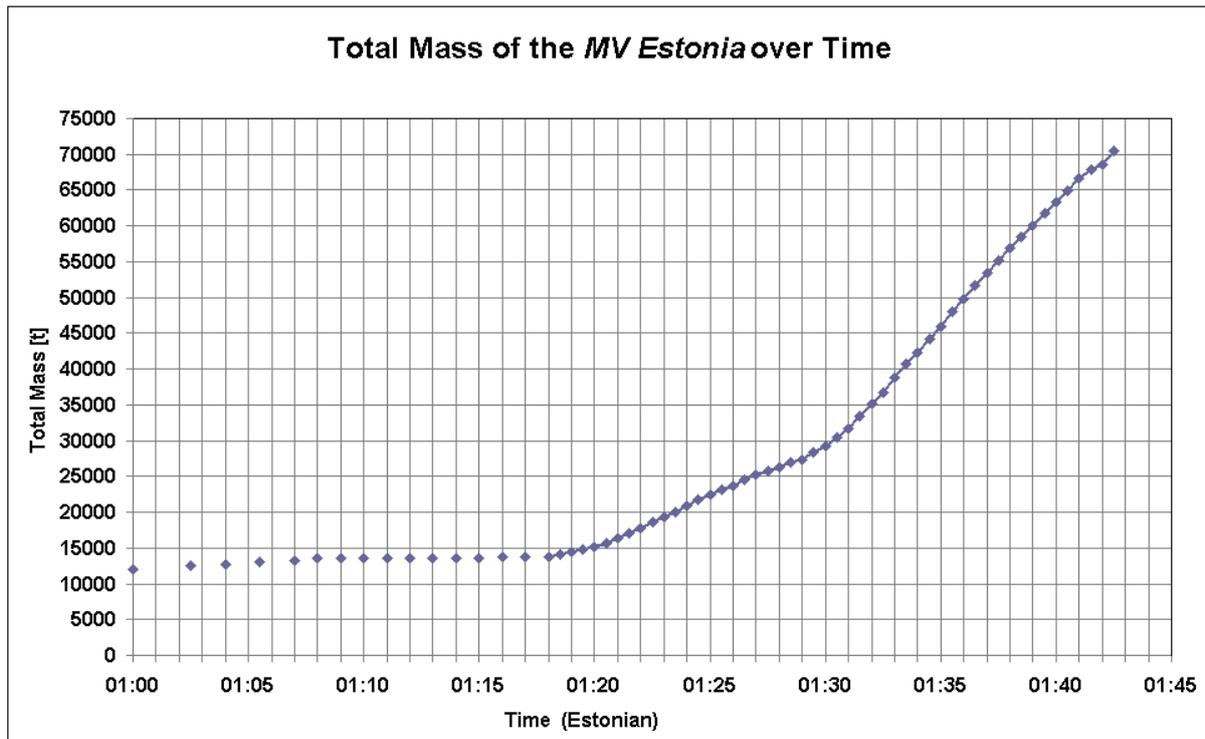
Fig. 50 Development of the total mass of the *MV Estonia* over time.

The development of the total mass of the *MV Estonia* as a function of time in Figure 50 shows a monotonous increase in the mass of the vessel. An acceleration of the sinking sequence beginning at about 01:30 can also be seen. This is in line with the testimonies of the survivors. This increase in the ship mass can also be seen as mass of water inflow per time step in Figure 51, which shows the average inflow per time step. The detailed data sheets to each floating position is given in the TUHH-report by Krüger and Kehren (2008).

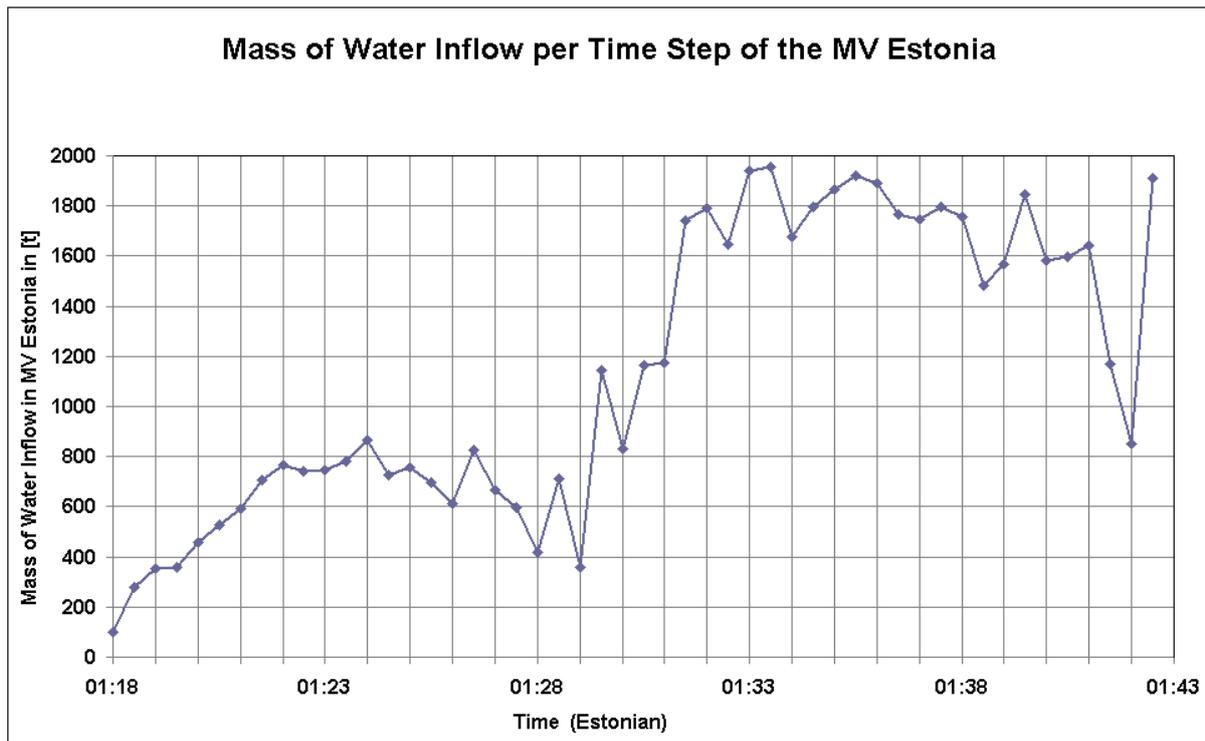
Fig. 51 Mass of Water Inflow as a function of time for the later phase of the sinking process.

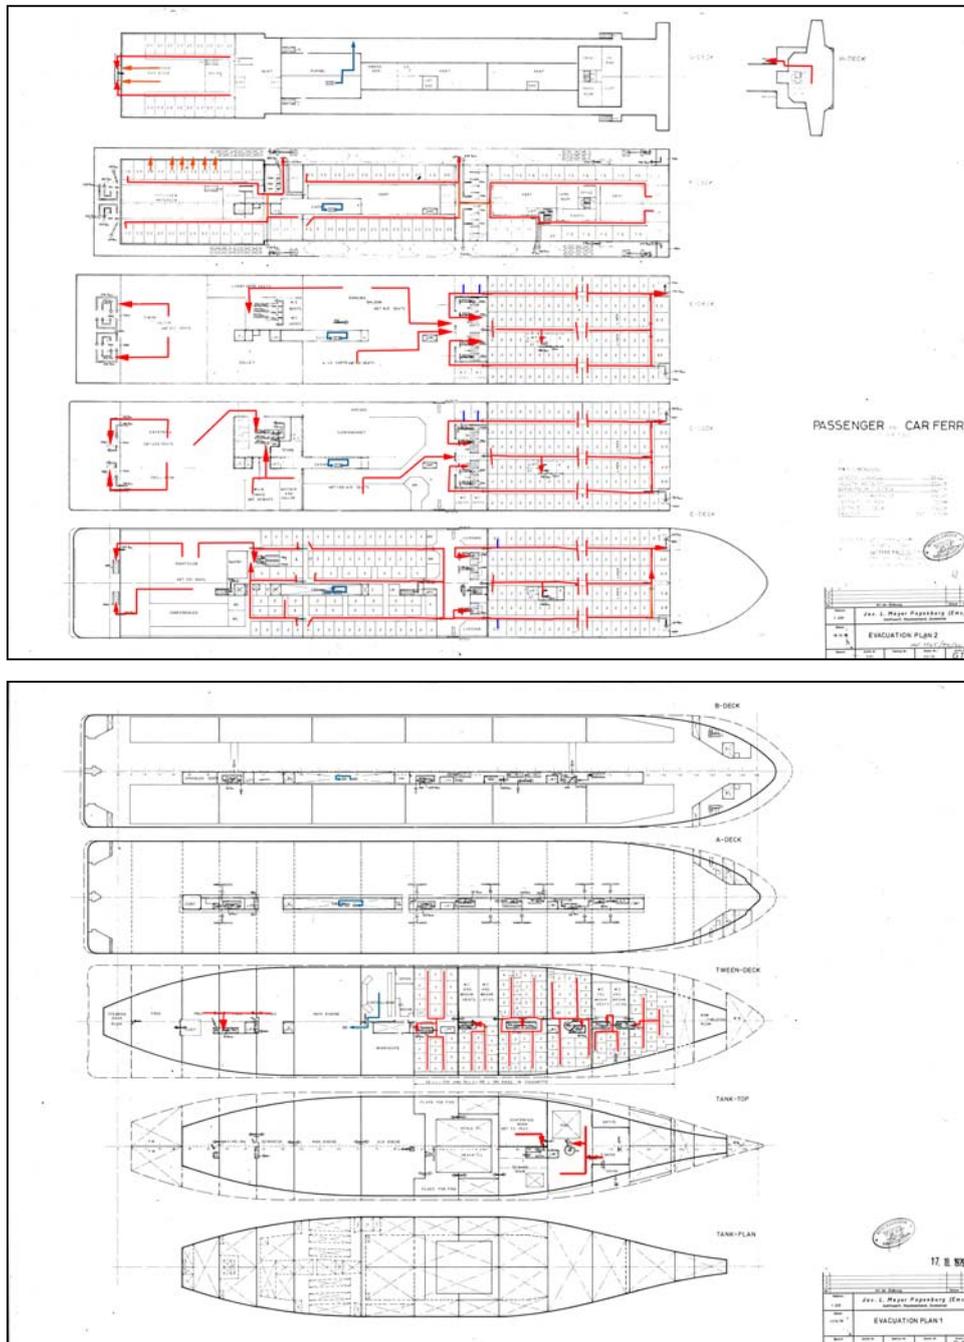
Fig. 62 Egress routes for case 3 (Real Case). The evacuation routes lead only to the port side of the ship due to the list. The three members of the crew in the ECR leave using the completely separate blue route.

The red egress routes in the Real Case are similar to those in the IMO Night and Day cases, but lead only to the higher port side of the vessel. The MV Estonia evacuation was in practice one-sided. Most survivors decided to get to the higher port side. There are only few individuals, who dived deep into the sea or were swept overboard by the waves to the starboard side of the vessel. Some of the crew members left their cabins on Deck 7 through the cabin windows directly on to the Deck 7. This is shown as additional red arrows pointing out through the cabin windows at the stern on Deck 7.

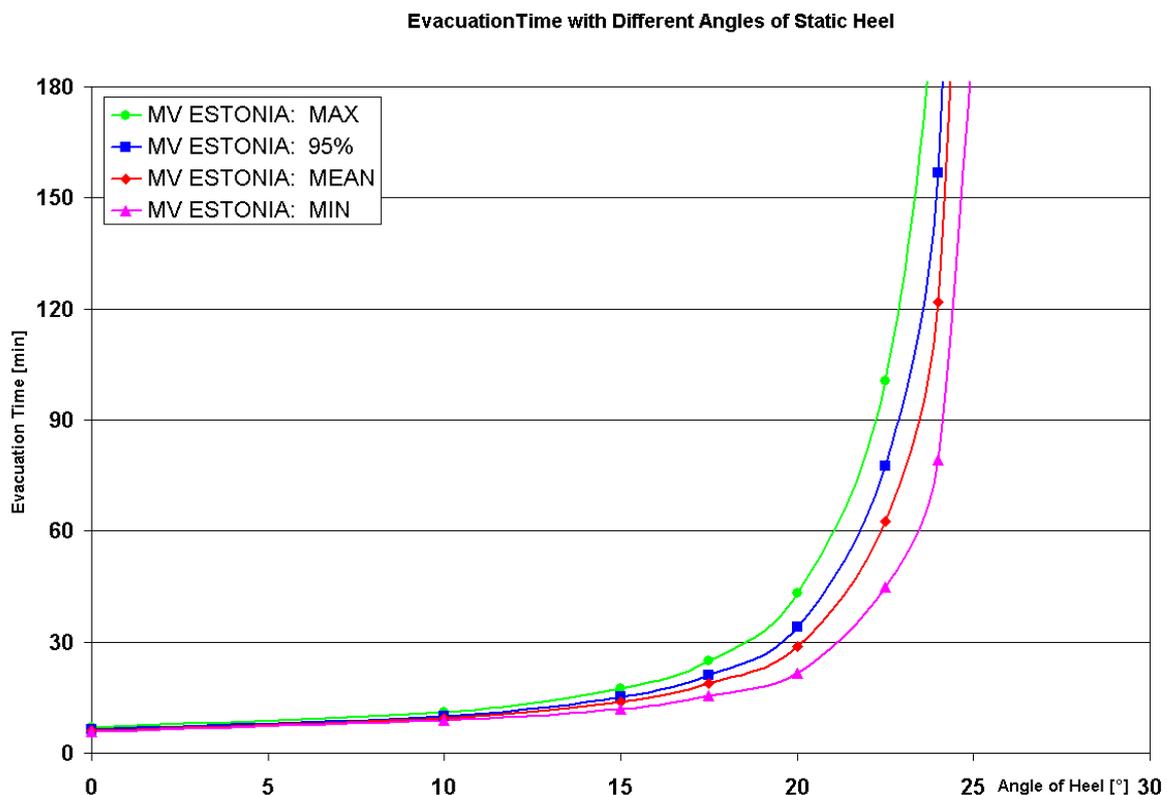
The computed evacuation times at different heeling angles are shown as curves in Figure 66. The small steady heeling angles do not cause significant problems to the passengers. When

Fig. 66 Evacuation times of the *MV Estonia* with different angles of list. Mean, maximum, minimum and 95 percentile curves of the 500 simulations are shown.

the heeling angle reaches 15° the evacuation time starts to show clear increase and beyond the heeling angle of 20° the evacuation time increases very rapidly with the heeling angle. Simultaneously the evacuation time distribution becomes significantly wider, that is, the difference between the shortest and the longest evacuation time of all passengers becomes larger.

- In an emergency it is important to carry out the evacuation early enough, when the inclination of a damaged ship is still sufficiently low. Evacuation of a ship having a large heeling angle can be very difficult.
