HSVA Report No. 1663

**Research Study on the Sinking Sequence
and Evacuation of the *MV Estonia*
- Final Report**

Client: VINNOVA

Hamburg, May 05, 2008

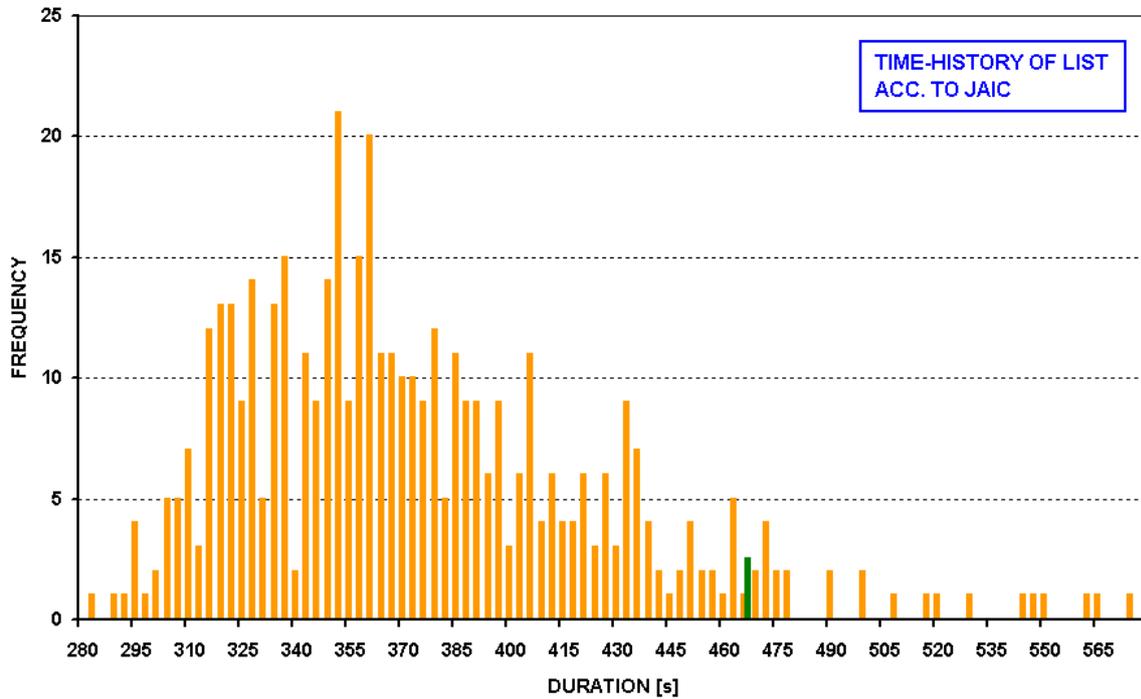
Fig. 68 Distribution of passenger evacuation times after exit of 300 persons from 500 simulations with AENEAS. This is the real case *MV Estonia* with the time history of list according to the JAIC Final Report. The green bar defines the 95 percentile, at which time in 95 percent of the simulated cases the passengers have reached the defined exits.

In case the TUHH-curve is used as input, 278 people succeed in getting out of the ship healing heavily. If the JAIC-curve with a corresponding start is used as input in the simulation, 307 people are able to get out of the ship. According to the JAIC Final Report at least 237, but probably about 310 persons could abandon the ship. Thus the simulated results appear to be plausible. A short comparison indicated that in those areas of the ship surveyed by divers after the accident, where bodies were found, also the evacuation simulations showed congestion, that is, the passengers models (agents) could not anymore advance due to the heavy list. Thus also in this respect the evacuation software used (AENEAS) appears to give good results. Based on the survivors' testimonies the *MV Estonia* evacuation or escape took place almost solely to the higher port side of the ship. Therefore also the *MV Estonia* real case is modeled as an evacuation to the port side only. The goal of the evacuation is the port side reeling on Deck 7, at which people climbed on to the ship side or were washed into the sea.

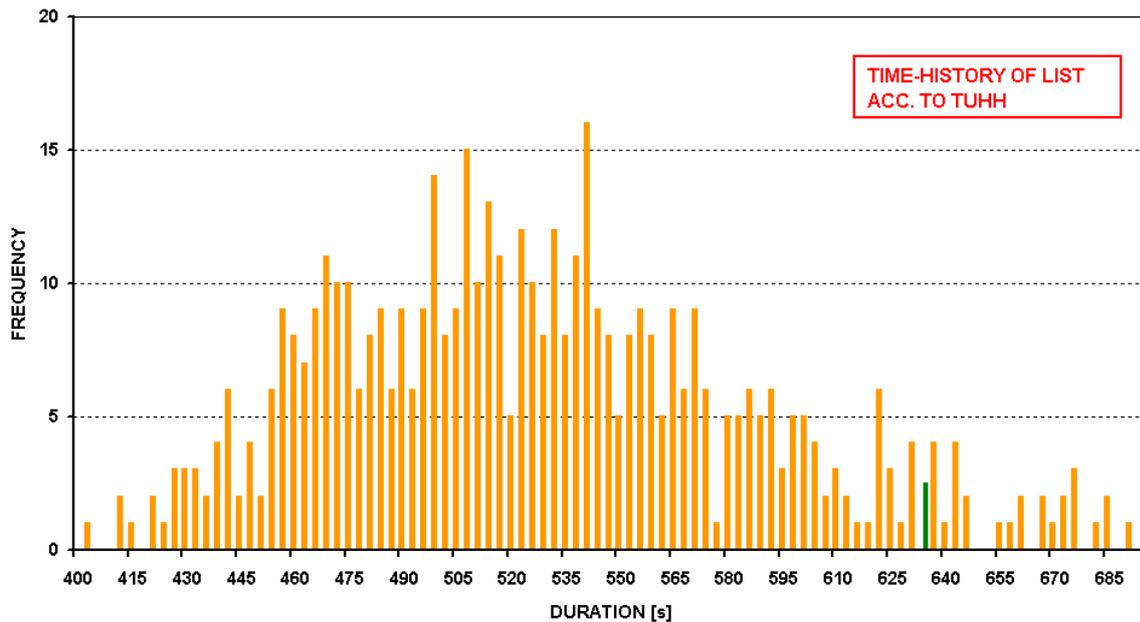
Fig. 69 Distribution of passenger evacuation times after exit of 270 persons from 500 simulations with AENEAS. This is the real case *MV Estonia* with the time history of list according to the TUHH. The green bar defines the 95 percentile, at which time in 95 percent of the simulated cases the passengers have reached the defined exits.

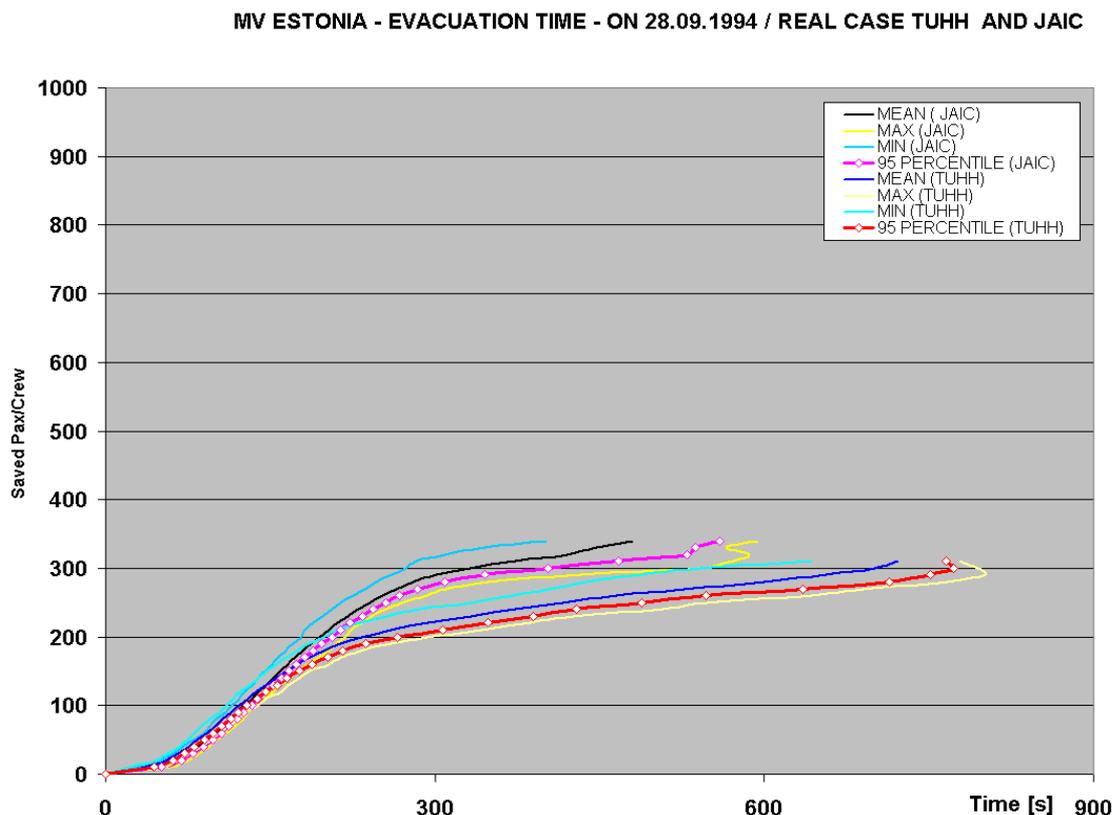
Fig. 70 Comparison of two evacuation simulations of the real *MV Estonia* on 28.09.1994 according to best available information on the accident. Two alternatives for the time-history of list are used: (1) According to JAIC; and (2) according to TUHH. In both cases the rapidly increasing list stopped the evacuation or the escape and only about 300 persons out of 989 got out of the ship.

Figure 70 shows the evacuation curves for time-history assumptions of JAIC and of TUHH. Even if the development of list according to JAIC and according to TUHH are somewhat different, in both cases the number persons succeeding in getting out of the ship remains below 350 out of all 989 persons on board in all simulations.

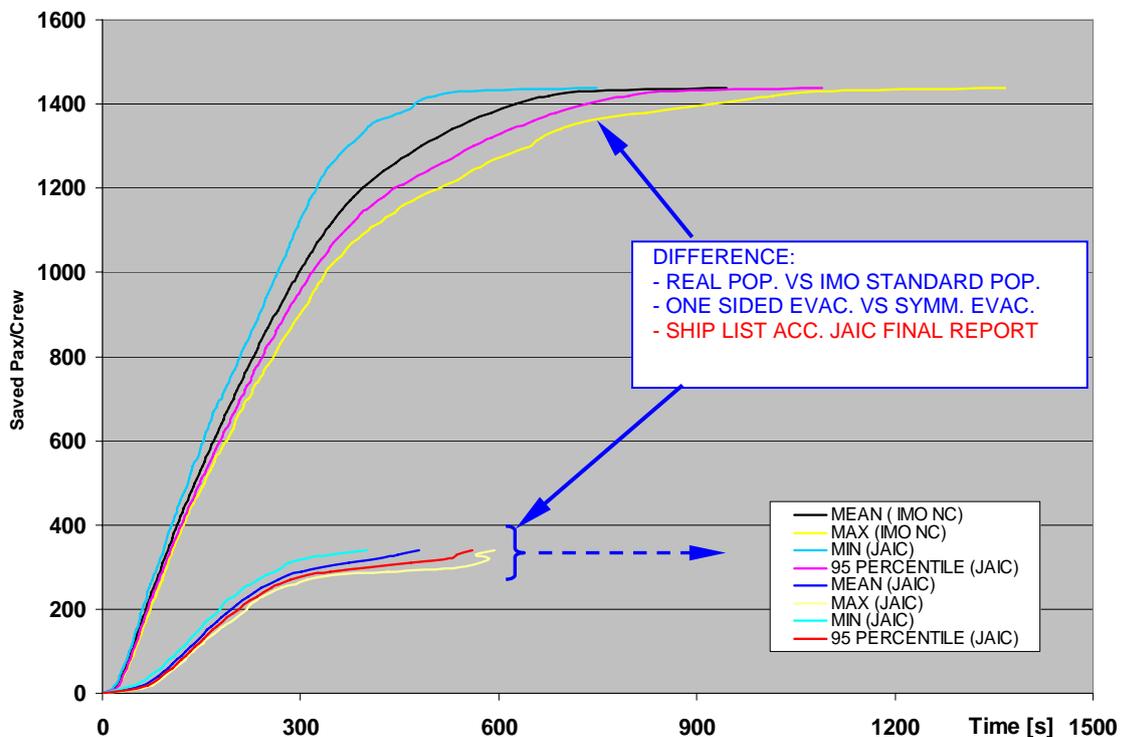
Figure 72 shows the comparison between the IMO Night Case and the real *MV Estonia* evacuation simulation with the ship list development based on the JAIC Final Report. The upper curve shows the evacuation process in the IMO standard Night Case. Such an information is available when a new vessel is designed, built and classified. The lower curve shows approximately how the evacuation proceeded during the *MV Estonia* accident. The increasing ship list practically stops the evacuation and only about 300 persons of the 989 are able to get out. These two curves show the “design case” and what turned out to be the reality in case of the *MV Estonia*. The difference is considerable.

Fig. 72 Comparison of the evacuation simulation of the standard IMO Night Case on *MV Estonia* and simulation of the real *MV Estonia* on 28.09.1994 according to best available information on the accident. In the real case the rapidly increasing list of the vessel stopped the evacuation or the escape and only about 300 persons out of 989 got out of the ship. The IMO standard case without ship heel does not reflect this problem.

The standard IMO Day- and Night Cases for advanced evacuation simulation are undoubtedly useful in ship design. The difference between the evacuation simulation according to the IMO Night Case, i.e. without ship list, and the real *MV Estonia* case is considerable, as also shown in Figure 72: The increasing ship list can significantly slow down or stop the evacuation process. Even if the *MV Estonia* is perhaps an extreme case, it can well be asked whether the IMO evacuation criteria should also deal with situations of non-zero ship list. In view of the *MV Estonia* case this can be seen as particularly important for vessels, which can rapidly develop a large list.

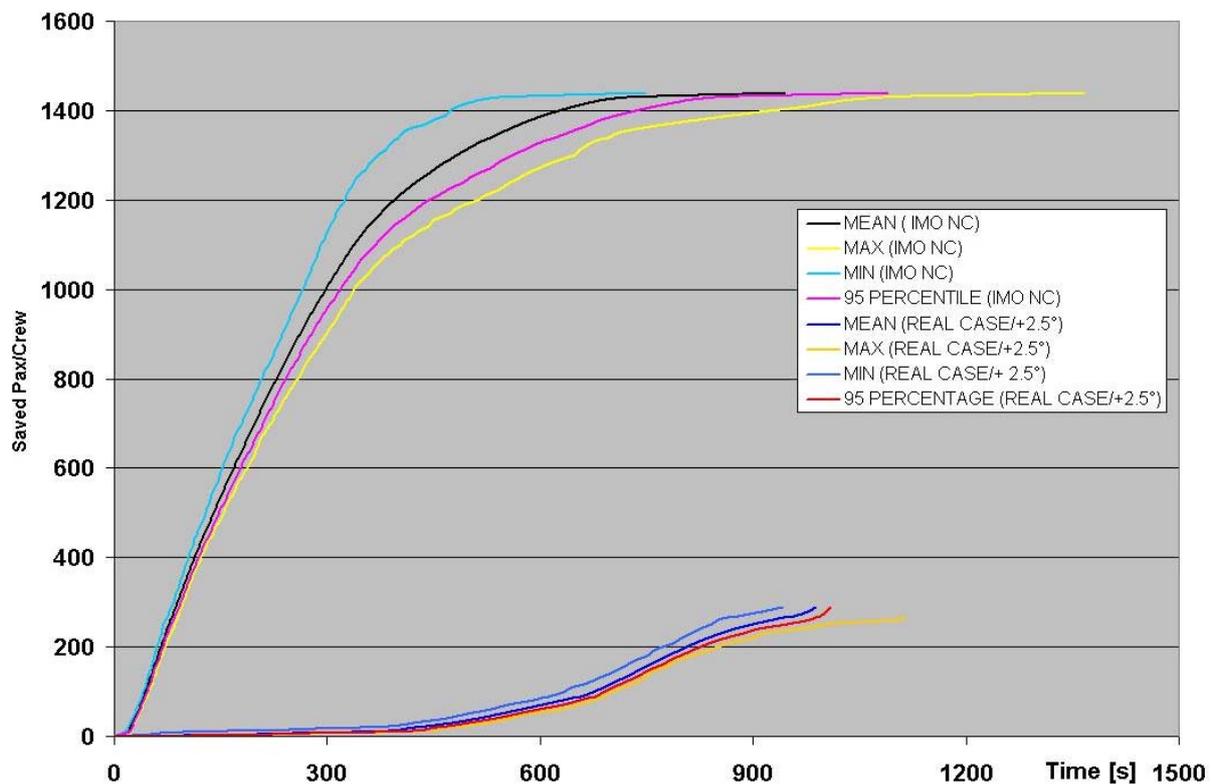
Fig. 74 The evacuation curves of the *MV Estonia* for the IMO Night Case (1439 persons onboard) and of the Real Case under the simulated roll and pitch motions (989 persons onboard). The ship’s heeling angle has been elevated 2.5° in the input data.

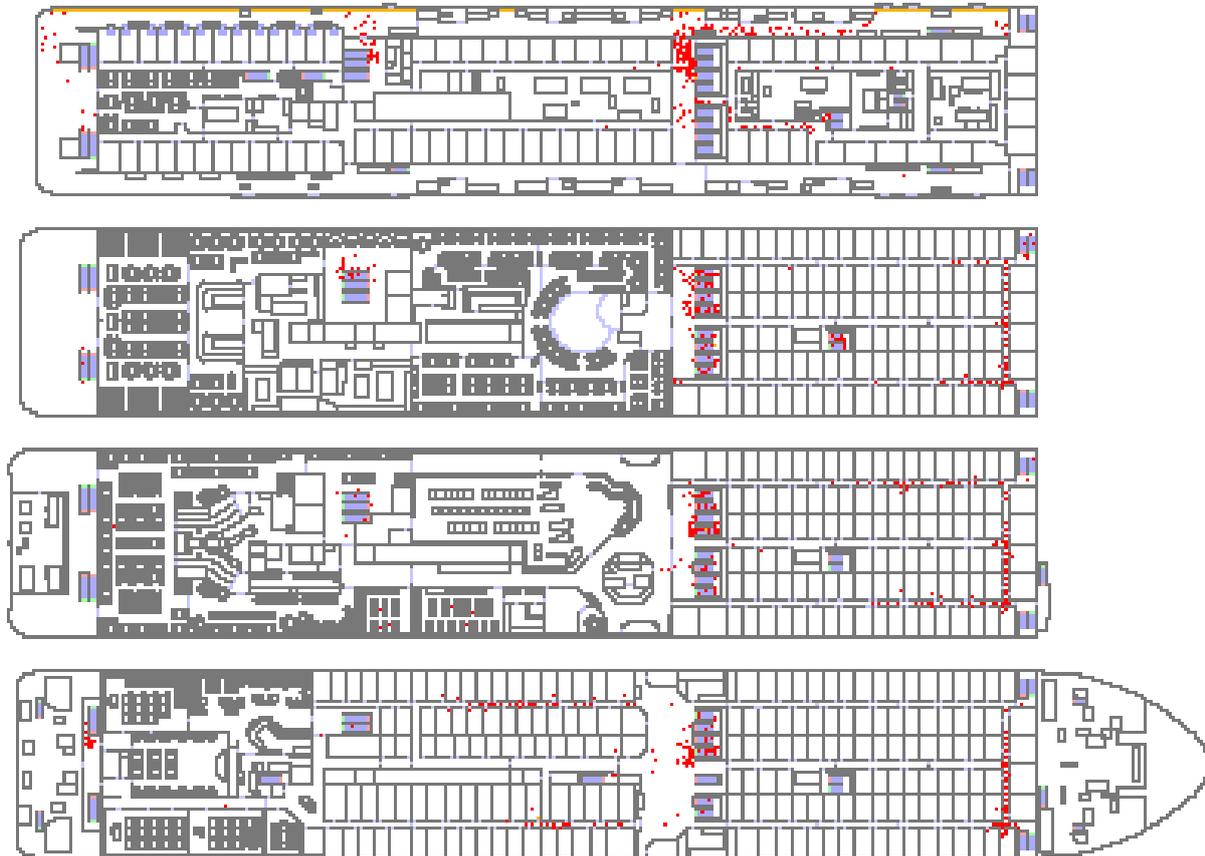
Figure 75 shows a screenshot of the evacuation process 18 min after the start. According to this simulation 296 persons got out of the ship. The red dots show the digital agents, which cannot anymore proceed due to the heavy list.

In this relatively late phase of the evacuation there are two areas of congestion: (1) the central main staircases with large open space around; (2) the transverse staircases in the very front part of the deckhouse.

(1) The main staircases are a central point in the evacuation routes, a congestion there may be unavoidable. The stairs are correctly laid in the longitudinal direction. The large open space around the stairs is difficult to cross at higher values of ship list. Thus on the basis of the evacuation simulation one could expect that the escape of many passengers ended up right here.

Fig. 75 A Screenshot of the evacuation process 18 min after the start. The red dots show the digital agents, which cannot anymore proceed due to the heavy list or congestion.

(2) The staircases at the front part of the deckhouse are built in transverse direction as shown in Figure 75. Usually staircases have an overall effective rise of about 30°. If the ship heels 20-30° the overall angle of a transverse staircase becomes 50-60°. Such a staircase forms in effect a dead end in the escape route. In the evacuation simulation, however, the agents cannot make a decision to change the escape route, if this turns out to be impassable. In reality most of those passengers, who tried this route must either have kept trying, got stuck between steep parts of the staircase or turned back and tried another route possibly ending up behind the other passengers. Thus the prerequisites for an effective evacuation in this area were not very good. Based on the

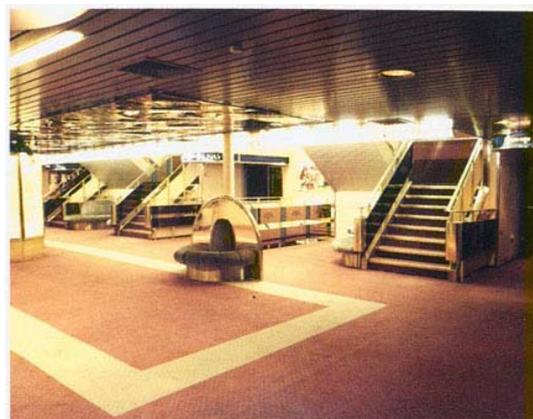
Fig. 76 The central staircases.

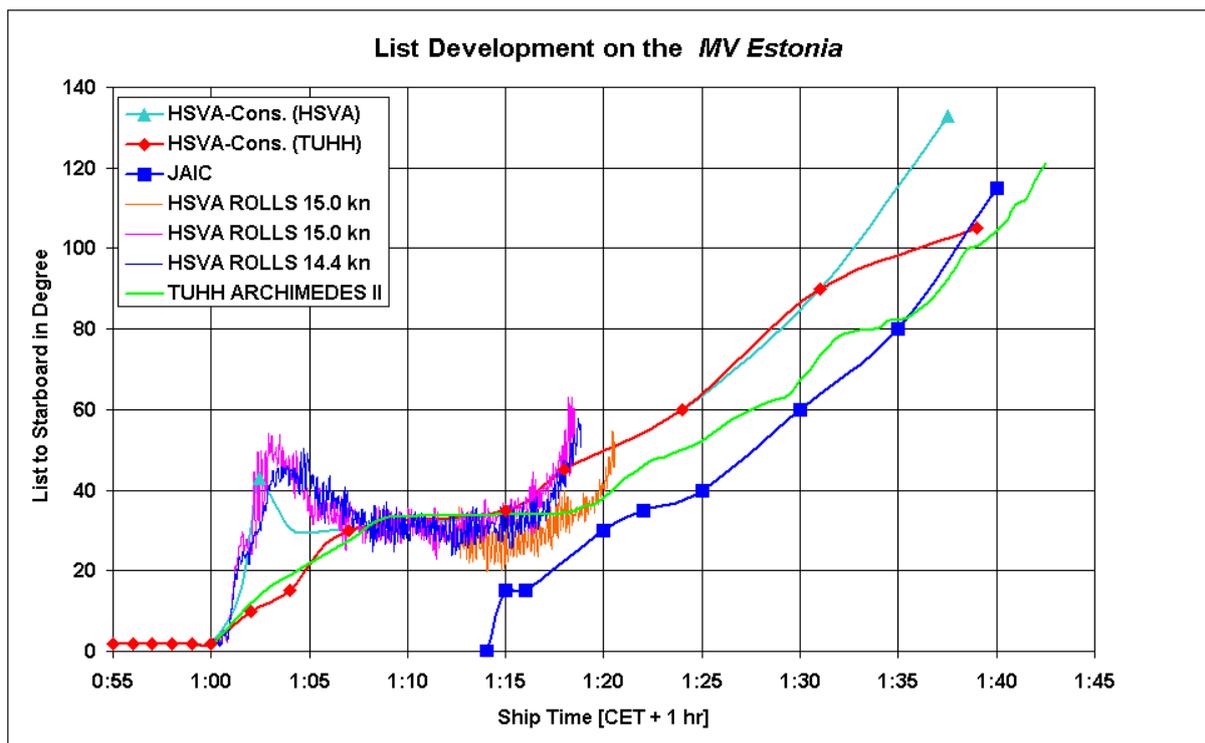
Fig. 78 The development of list on the *MV Estonia* reconstructed from the survivors' testimonies and computed with numerical models.

As one can see in Figure 78 the curves computed with the HSVA ROLLS and the ARCHIMEDES II cover the whole sinking sequence, and correlate satisfactorily with the two empirical curves established by the HSVA-Consortium.

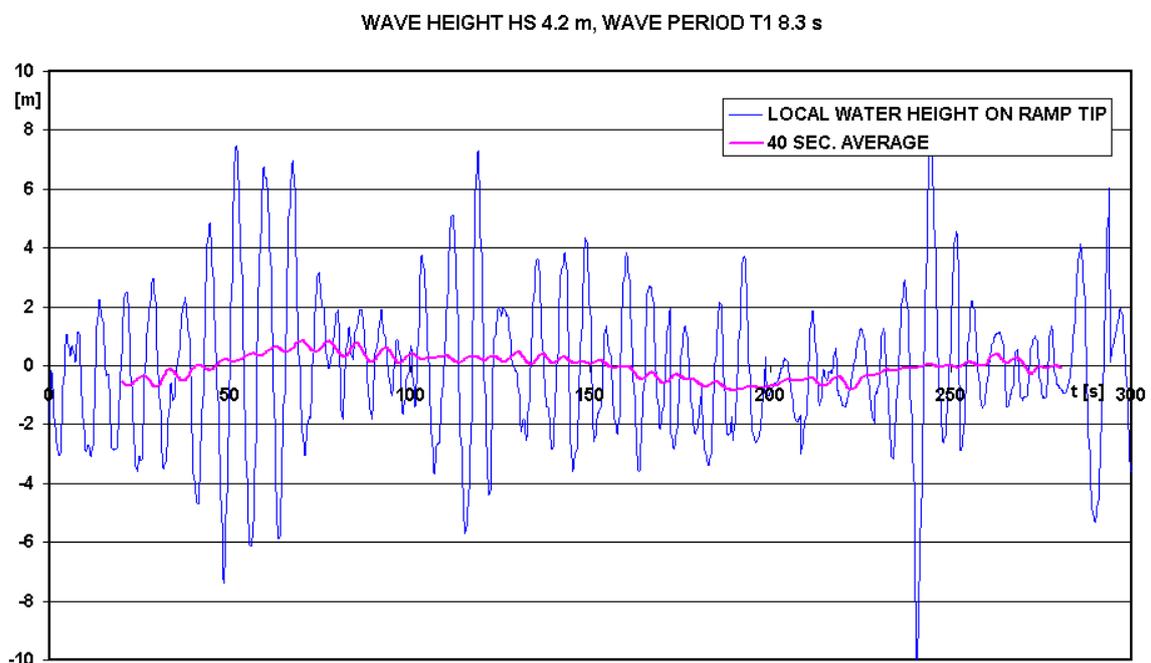
Fig. A17 Water height on the ramp tip. Significant wave period 8.3 s. The situation corresponds to the first 300 s of the ship roll motion behavior shown in Figure 40.

In order to get some additional light on the issue the water height on tip of the open ramp was plotted for two different significant periods, namely for 6.9 s and 8.3 s. The corresponding modal periods are 8.3 s and 9.9 s, respectively. Figures A17 and A18 show in addition to the momentary values of the water height on the tip of the open bow ramp also as a running average value over 40 s, providing an averaged curve of the water height on the ramp tip. With a period of 8.3 s this value is partly negative, that is, the tip located higher than the local wave elevation, and partly positive, that is, there is water on the ramp tip. With a period of the 6.9 s the averaged curve shows that there is no water on the ramp tip, which could flow onto the ship due to the ship speed. This difference may be due to (1) modeling errors in the numerical model, (2) differences between the modal wave periods of the sea state hindcasted for the *MV Estonia* accident and the periods of the waves the *MV Estonia* actually met during the accident.

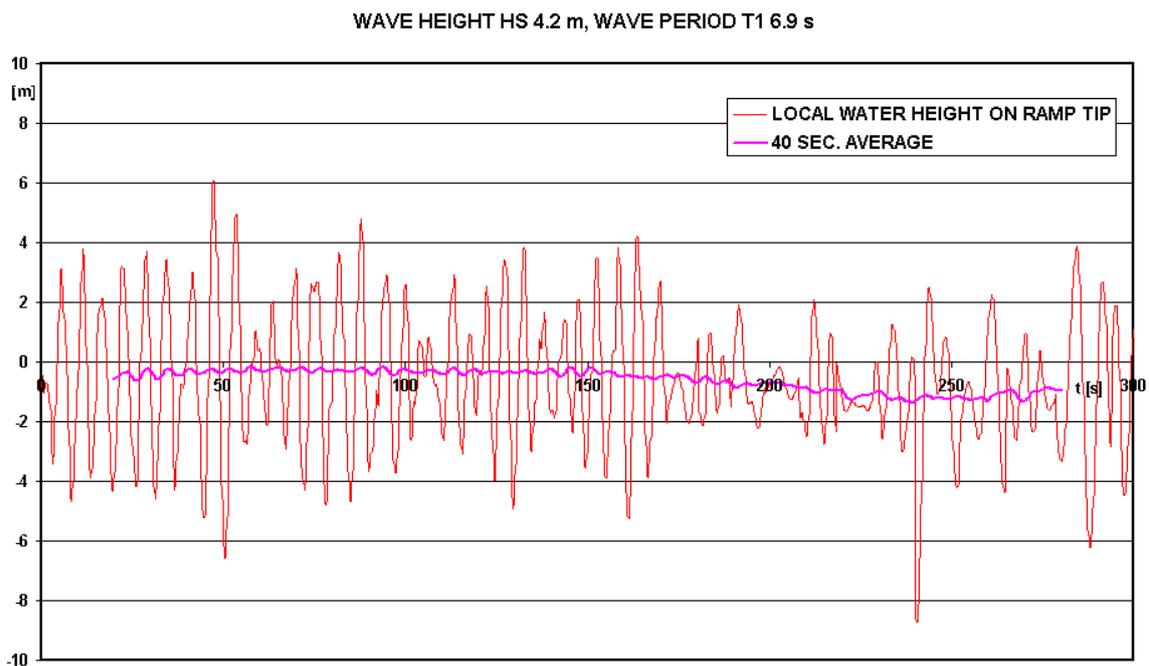
Fig. A18 Water height on the ramp tip. Significant wave period 6.9 s.
